Technical Report – R4790237930 CWCT – Standard for systemised building envelopes – 2005

Wienerberger Limited

**Corium Brick Cladding with Floorspan
Rainscreen Cladding Support System**

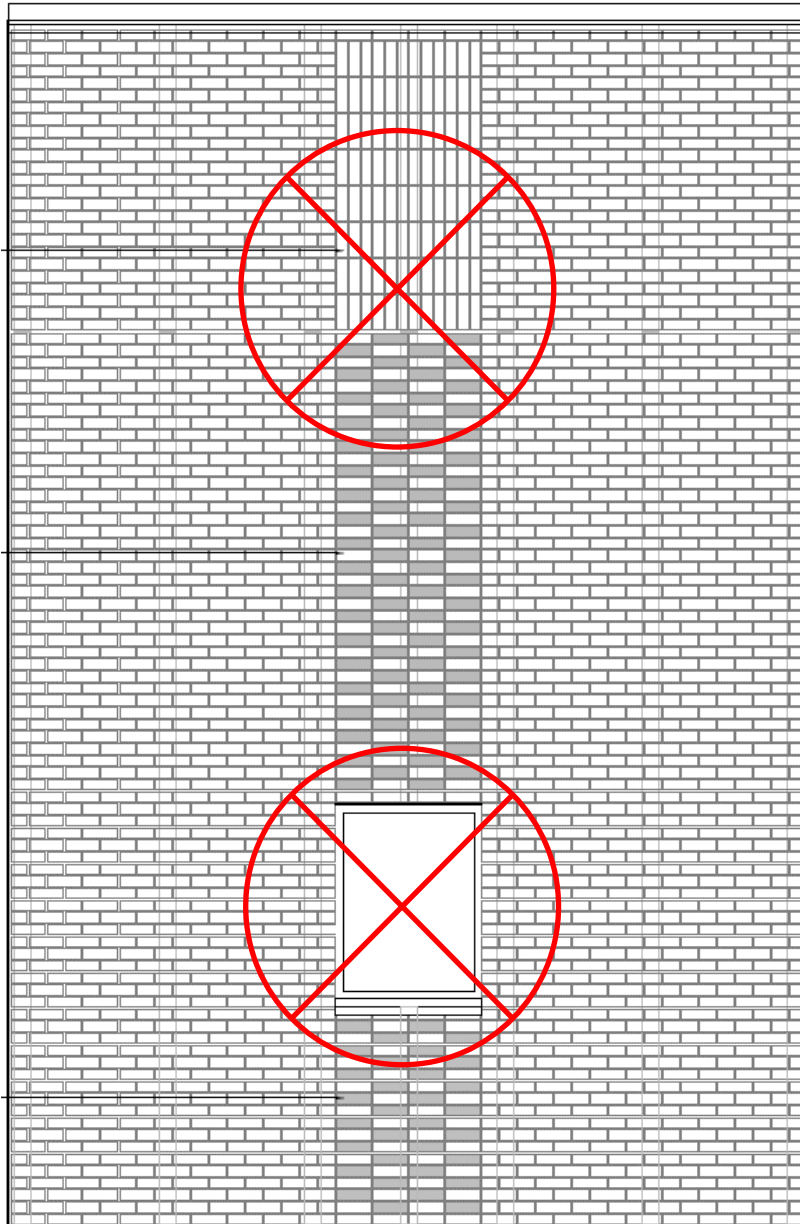
Figure 2

The sample was subjected to testing as described in section 5.2.1, for a period of not less than 15 minutes, during which no water leakage was observed through the sample.

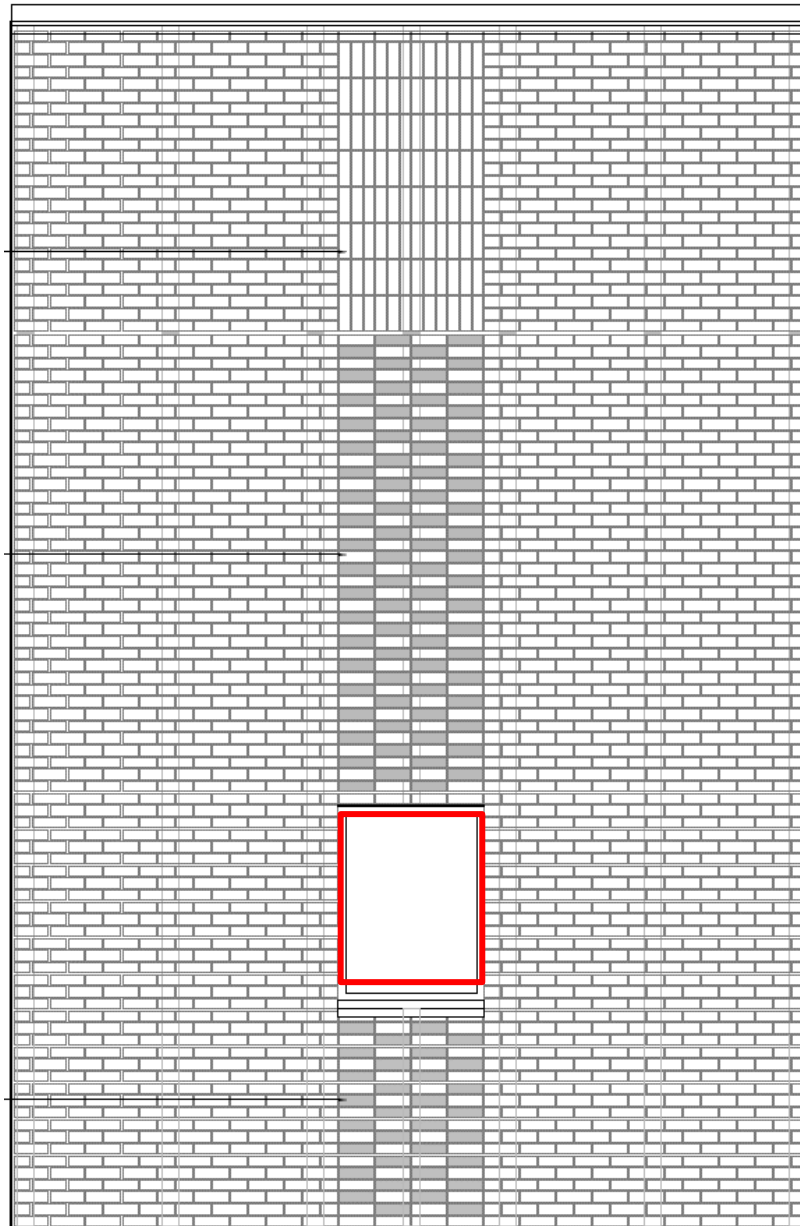
Figure 3

The sample was subjected to hose testing, as described in section 5.2.2. During the test, and for 30 minutes following the cessation of spraying, the sample was monitored for water ingress and none was found.

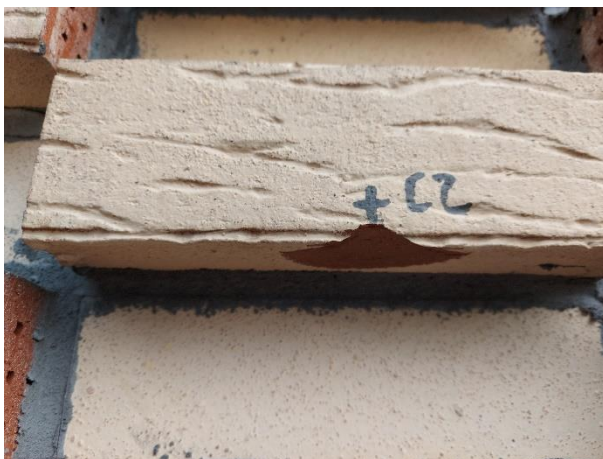
Photograph No. 3

Showing damage caused following impact reference C2 on the orange zone

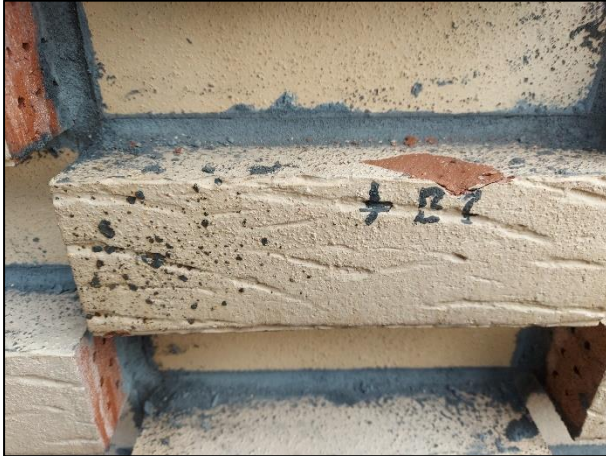
Photograph No. 4

Showing damage caused following impact reference B2 on the orange zone

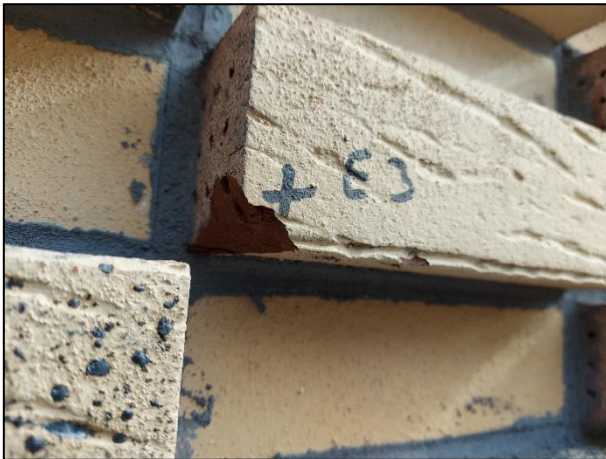
Photograph No. 5

Showing damage caused following impact reference E3 on the orange zone

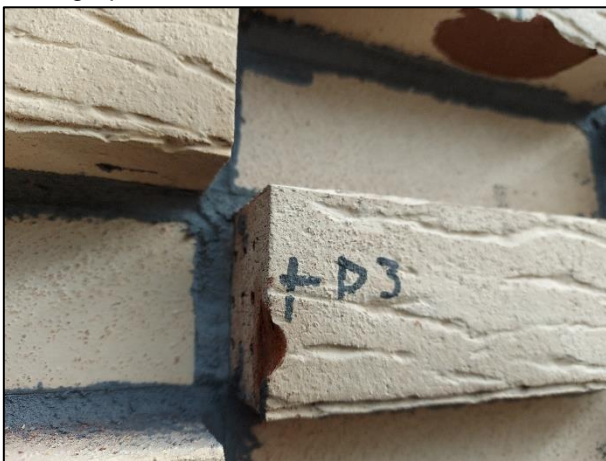
Photograph No. 6

Showing damage caused following impact reference D3 on the orange zone

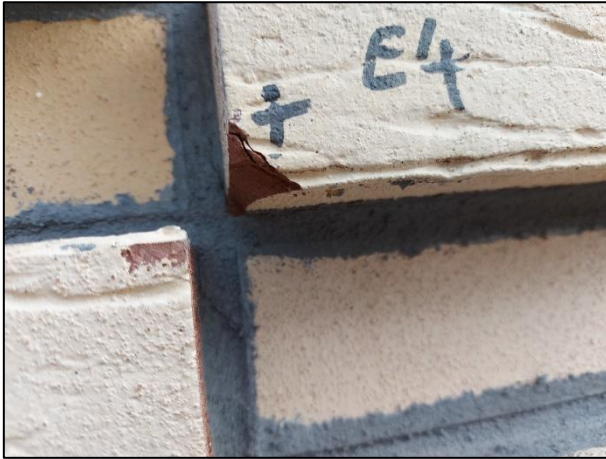
Photograph No. 7

Showing damage caused following impact reference E4 on the orange zone

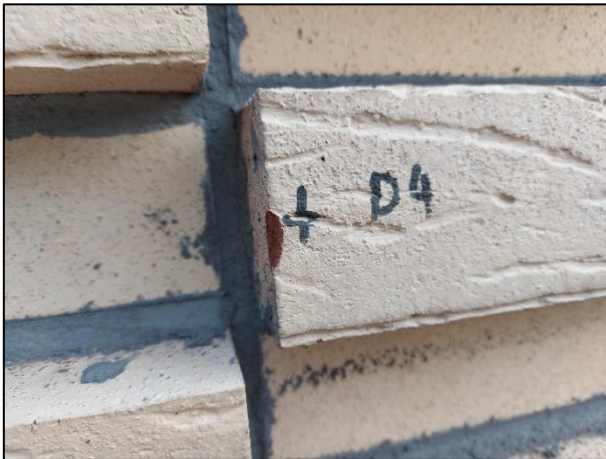
Photograph No. 8

Showing damage caused following impact reference D4 on the orange zone

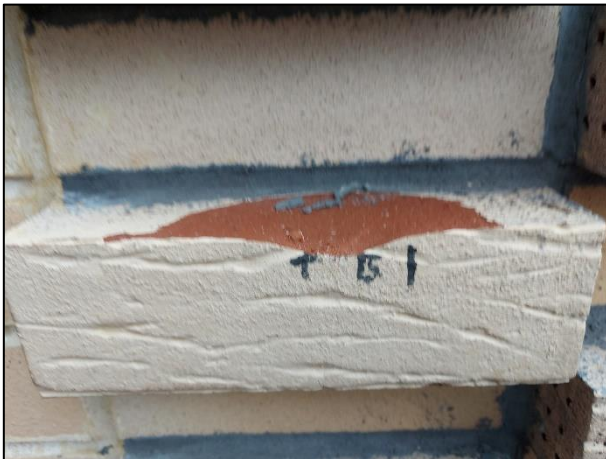
Photograph No. 9

Showing damage caused following impact reference B1 on the orange zone

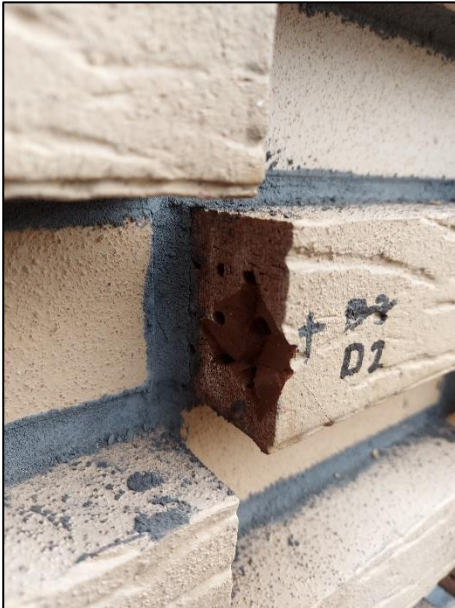
Photograph No. 10

Showing damage caused following impact reference D2 on the orange zone

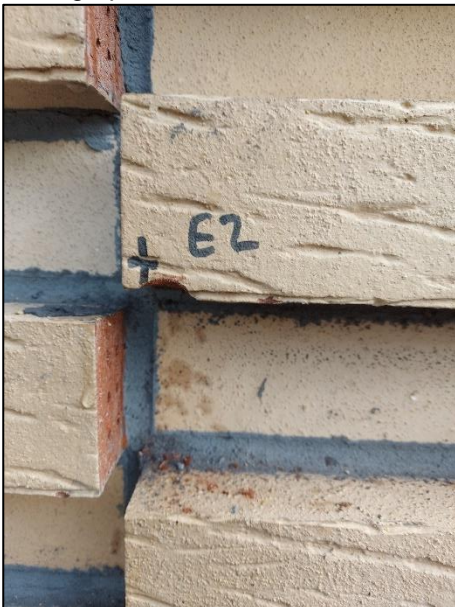
Photograph No. 11

Showing damage caused following impact reference E2 on the orange zone

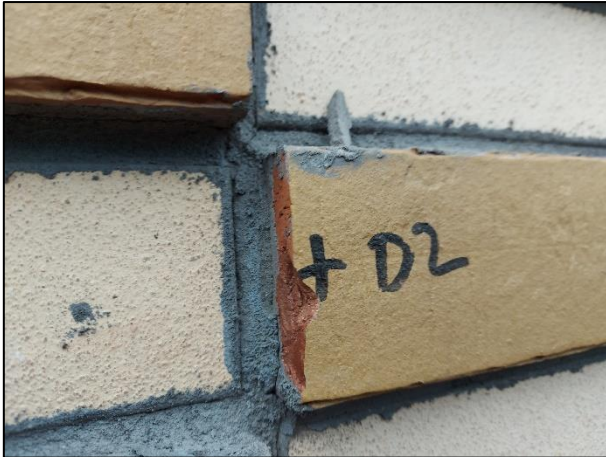
Photograph No. 12

Showing damage caused following impact reference D2 on the green zone

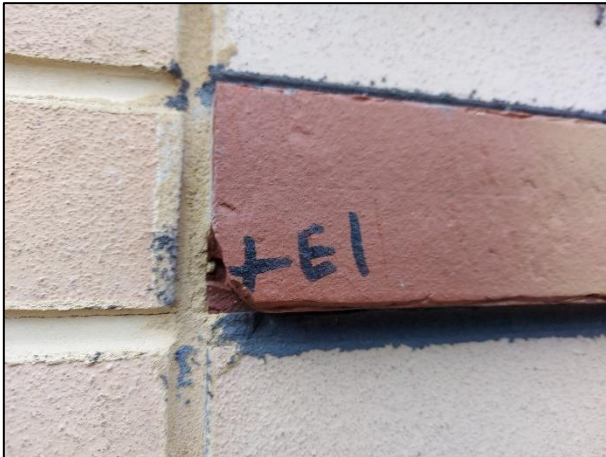
Photograph No. 13

Showing damage caused following impact reference E1 on the green zone

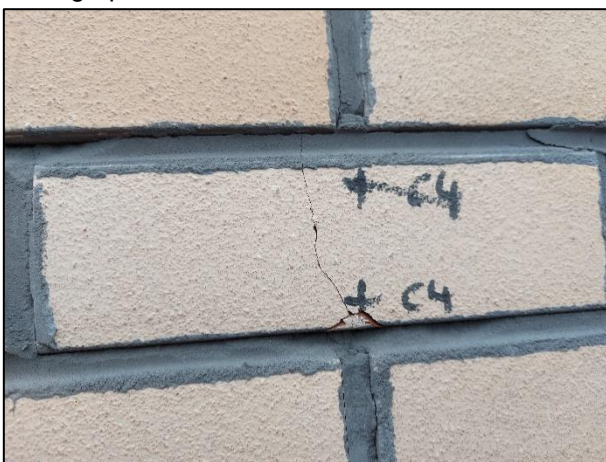
Photograph No. 14

Showing damage caused following impact reference C4 on the blue zone

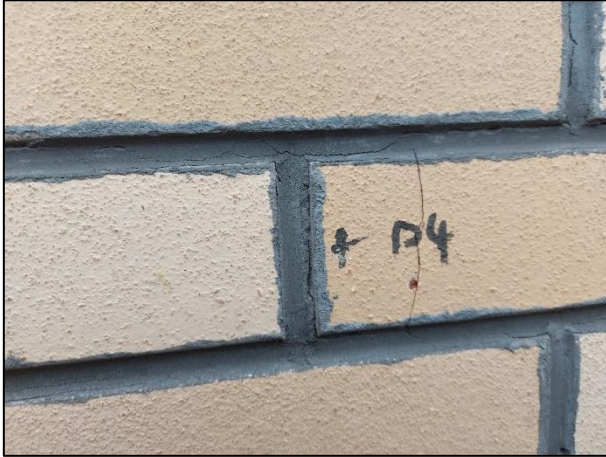
Photograph No. 15

Showing damage caused following impact reference D4 on the blue zone

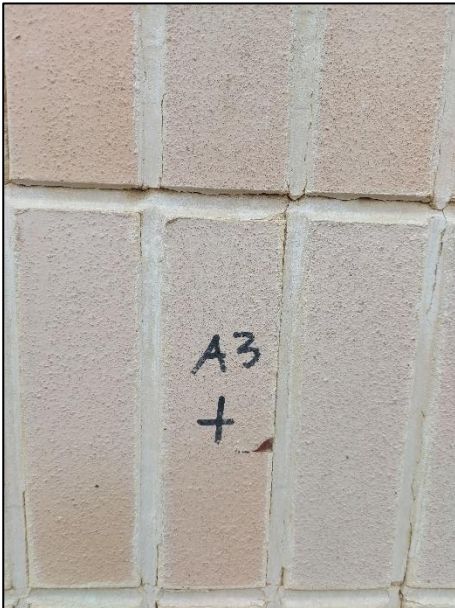
Photograph No. 16

Showing damage caused following impact reference A3 on the red zone

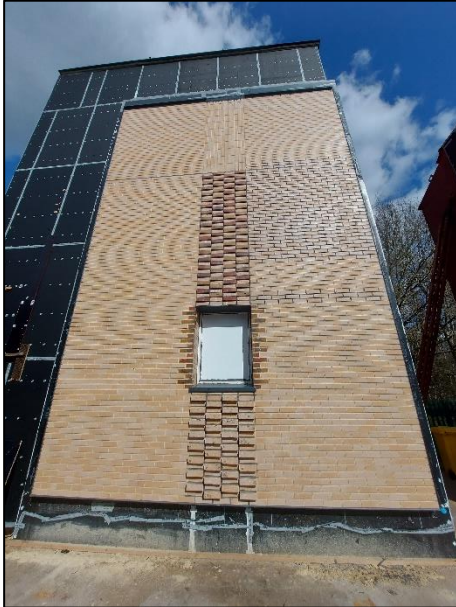
Photograph No. 17

There was no water evident in the system in parts designed not to be wetted, and it was found that the system fully complied with the system drawings in Section 7 provided by Wienerberger Limited at the time of the dismantle.

Sample prior to dismantle

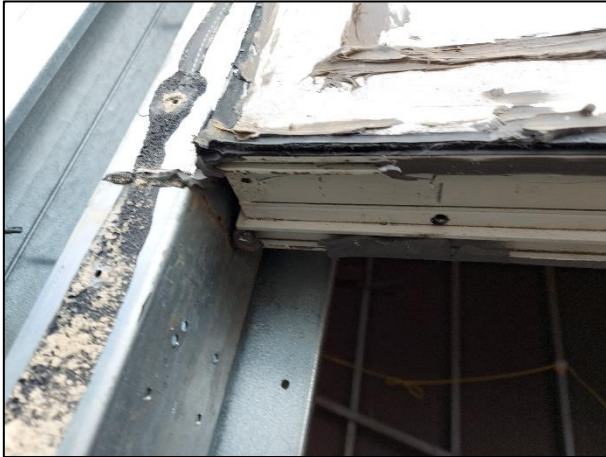
Photograph No. 23

Bottom of window system

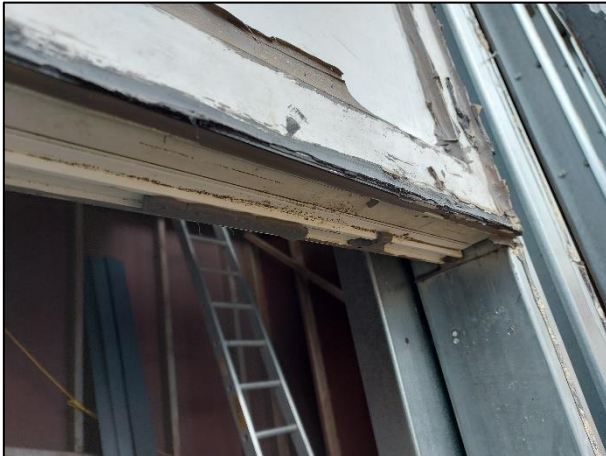
Photograph No. 24

Bottom of window system
