BRE Global Test Report

BS 8414-2:2015 + A1:2017 Test on 3mm-thick aluminium cassette panels with 150mm-thick Rockwool Rainscreen Duo Slab insulation

Prepared for: SBS Cladding

Report Number: P119916-1000 Issue: 2

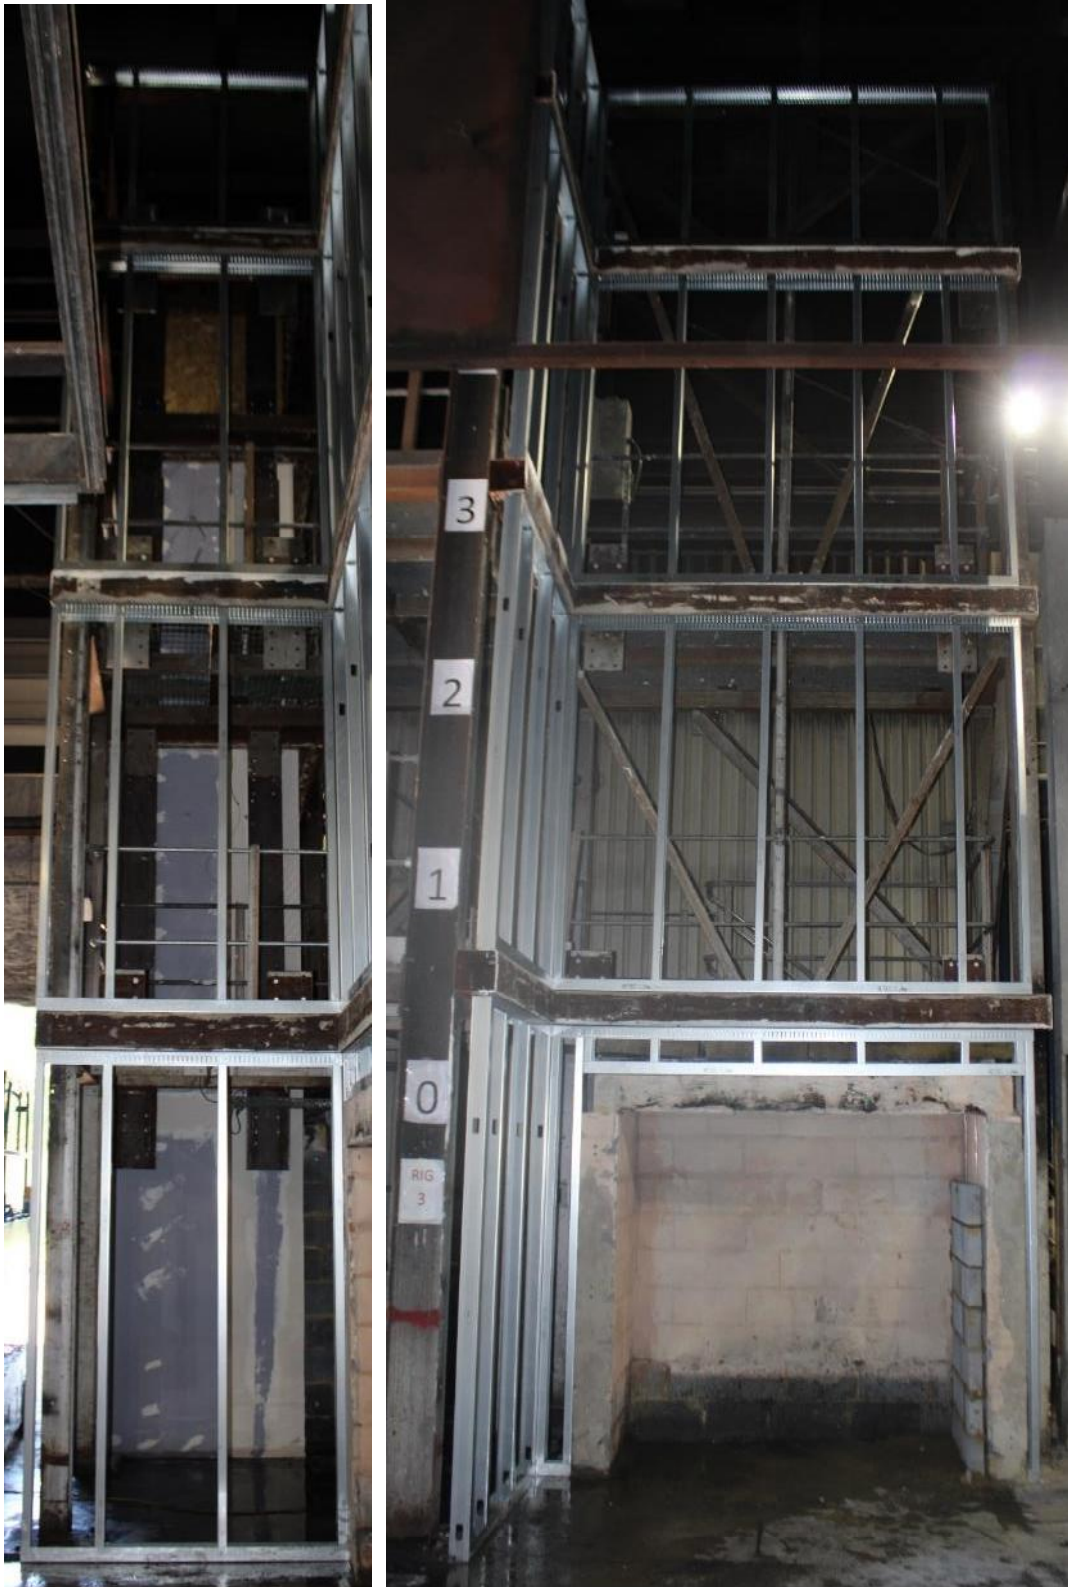
Figure 2. Installation of steel framing system (SFS).

Head tracks (Item 1) were fixed to the underside of the SHS at every level (20mm behind the front face of the SHS) and to the steel angle at the top of the system, with 5mm×37mm self-drilling screws with EPDM washers. Fixings at nominal 600mm horizontal centres.

Base tracks (Item 2) were fixed to the ground and topside of the SHS at every level in line with the head tracks, with DEWALT DWT1400150 SP 6.3mm×45mm screws (to ground) and 5mm×37mm self-drilling screws with EPDM washers (to SHS). Fixings at nominal 600mm horizontal centres.

Vertical studs (Item 3) were fixed between the head and base tracks, with TIMCO 5.5mm×25mm self-drilling screws, four fixings per stud located: front/back at top (through movement slot) and front/back at base. The stud centres were at 600mm with the spacing at main and wing wall outer edges reduced to 430mm and 412mm respectively. An additional stud was installed at ground level, adjacent to the combustion chamber wall, 195mm from the main-wing wall junction.

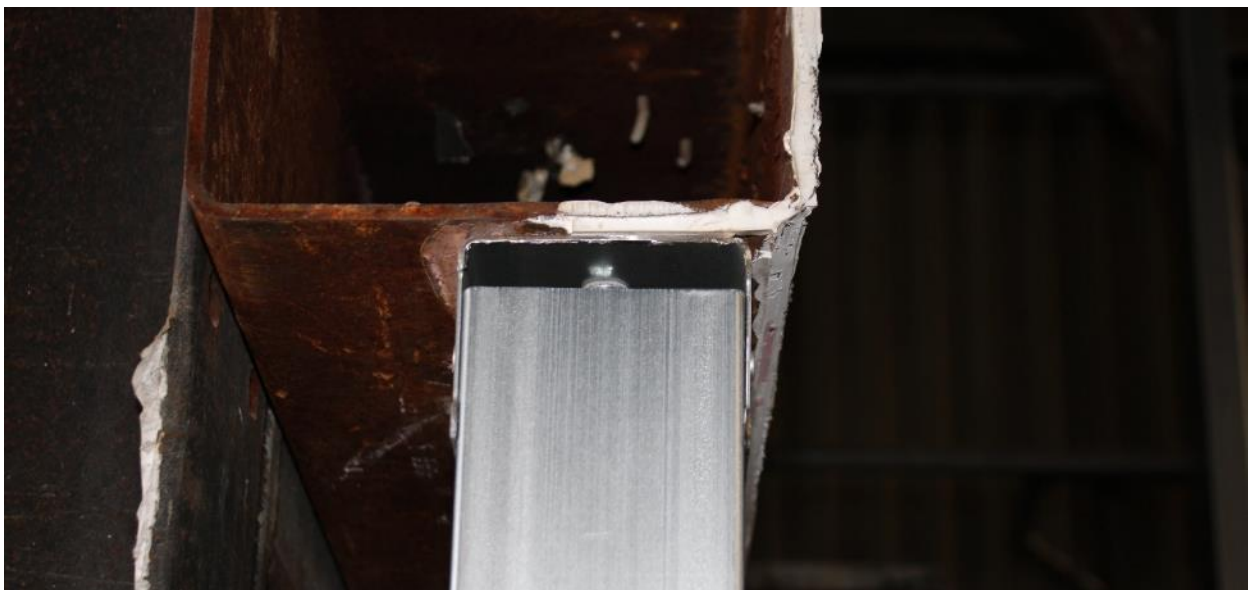
Figure 4. SFS location on the square hollow section (SHS).

200mm×200mm×6mm Square Hollow Section (SHS) steel beams were fitted as part of the BRE test rig at 2530mm, 5070mm and 7550mm from ground to underside of section. At the top of the apparatus was a 150mm×150mm×6mm steel angle, 9030mm from ground. These were the primary attachment points of the cladding system to the test rig.

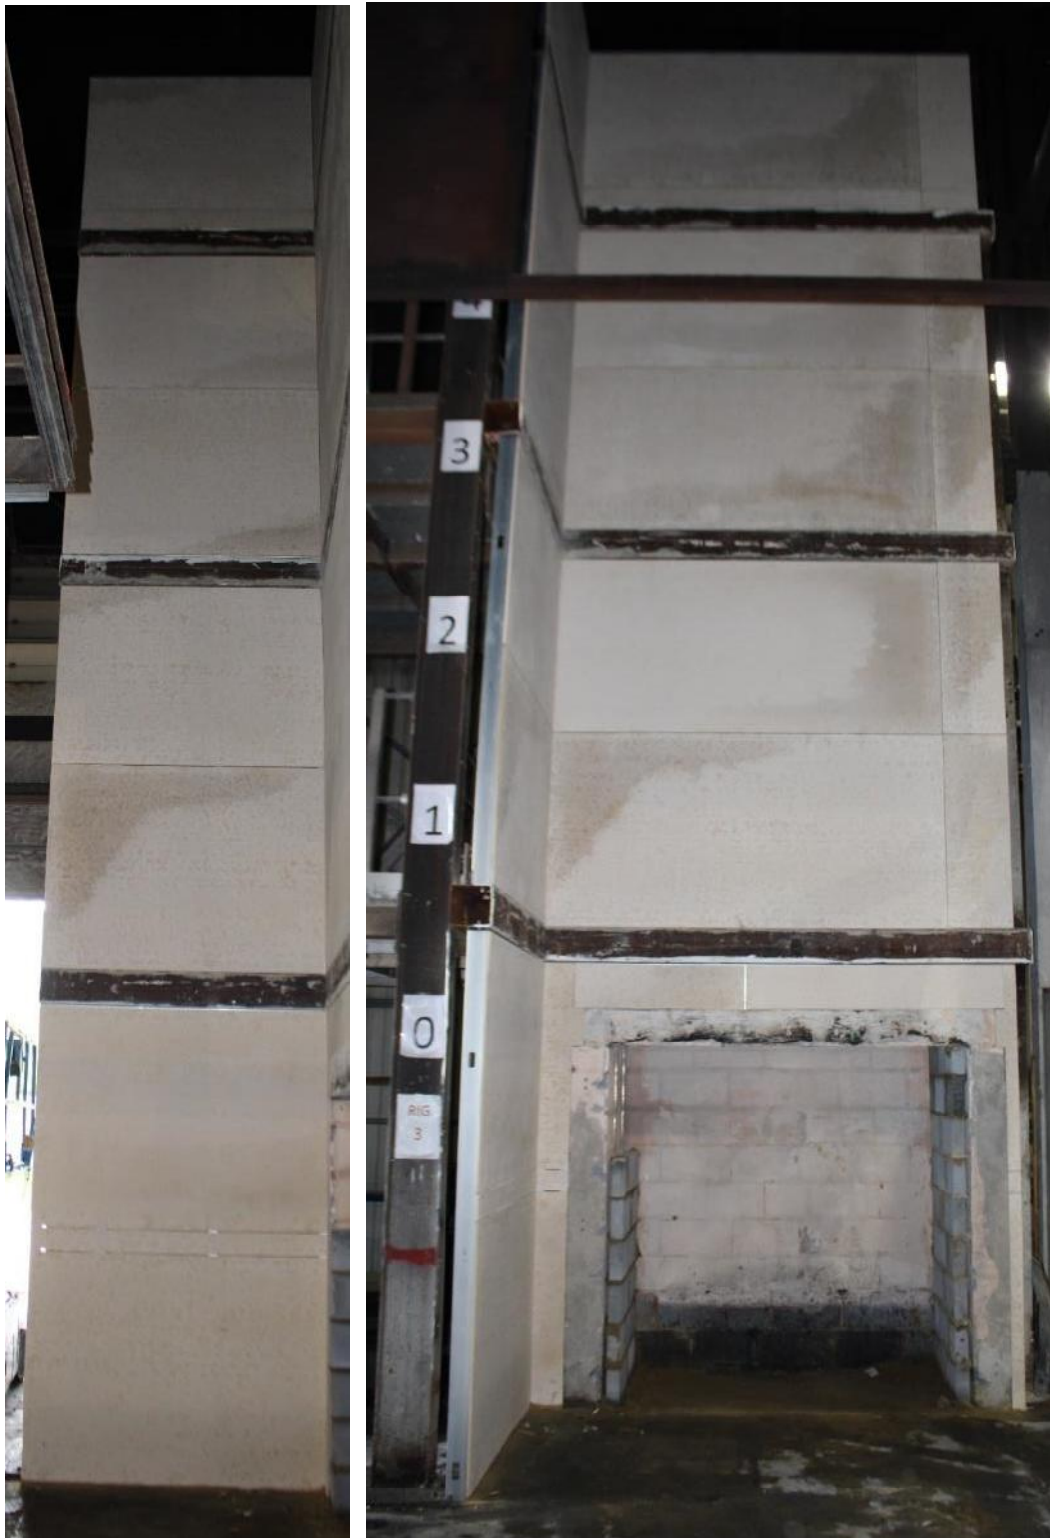
Figure 5. Installation of sheathing board.

Sheathing boards (Item 4) were fixed to the vertical studs (Item 3) as horizontal boards, with Evolution TSTF4.8-45-3 (4.8×45mm) self-drilling screws at 300mm vertical centres.

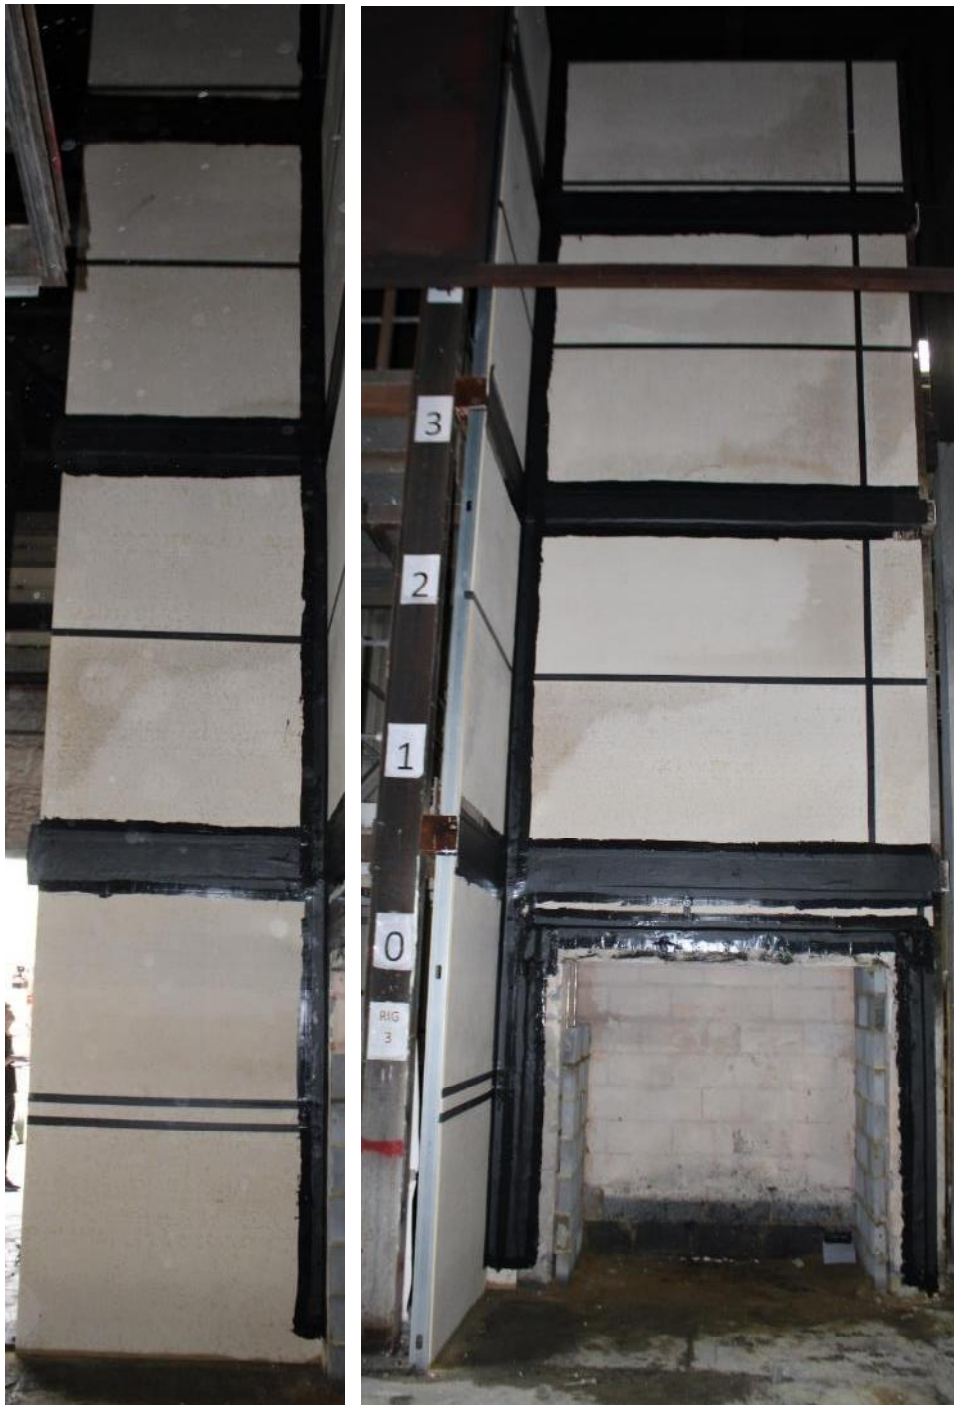
Figure 6. Installation of EPDM membrane.

Self-adhesive EPDM membrane (Item 5) was applied to vertical and horizontal sheathing board joints and at the main-wing junction.

A 350mm-high section of fire-retardant EPDM membrane (Item 6) was applied to the sheathing board-SHS joints and combustion chamber-sheathing board joints. The membrane was fixed in place with Cortex paste adhesive (Item 7).

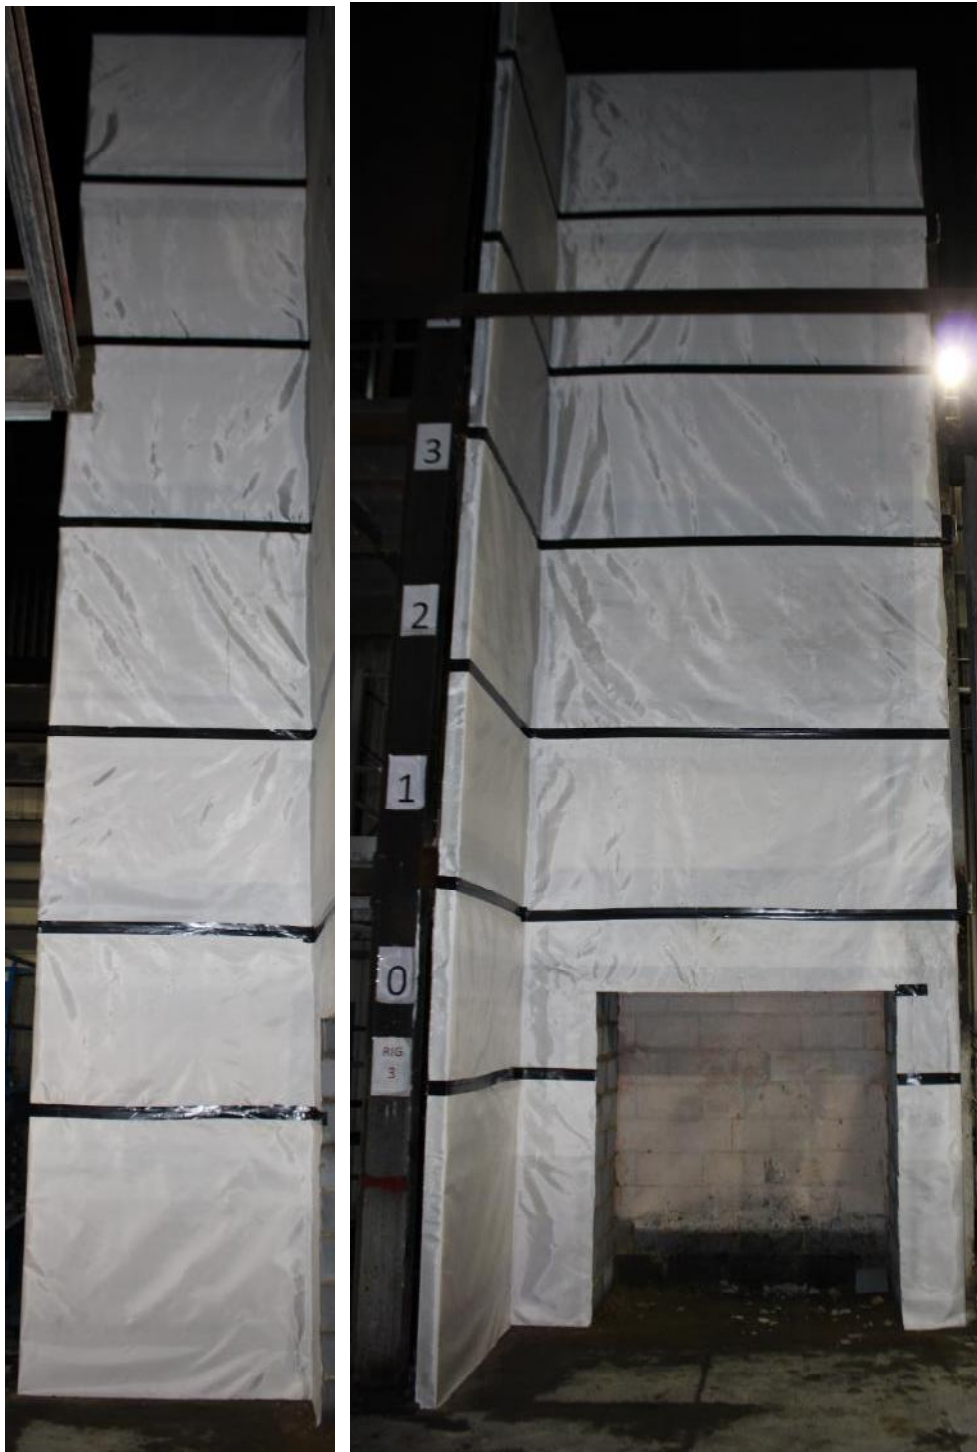
Figure 7. Installation of the breather membrane.

Breather membrane (Item 8) was fixed to the system in horizontal rows, with approx. 200mm overlap per section. The rear side of the membrane was secured with Cortex double-sided tape (Item 9) vertically and horizontally as each section was applied. The joints on the front face were sealed with Cortex UV Façade Tape (Item 10).

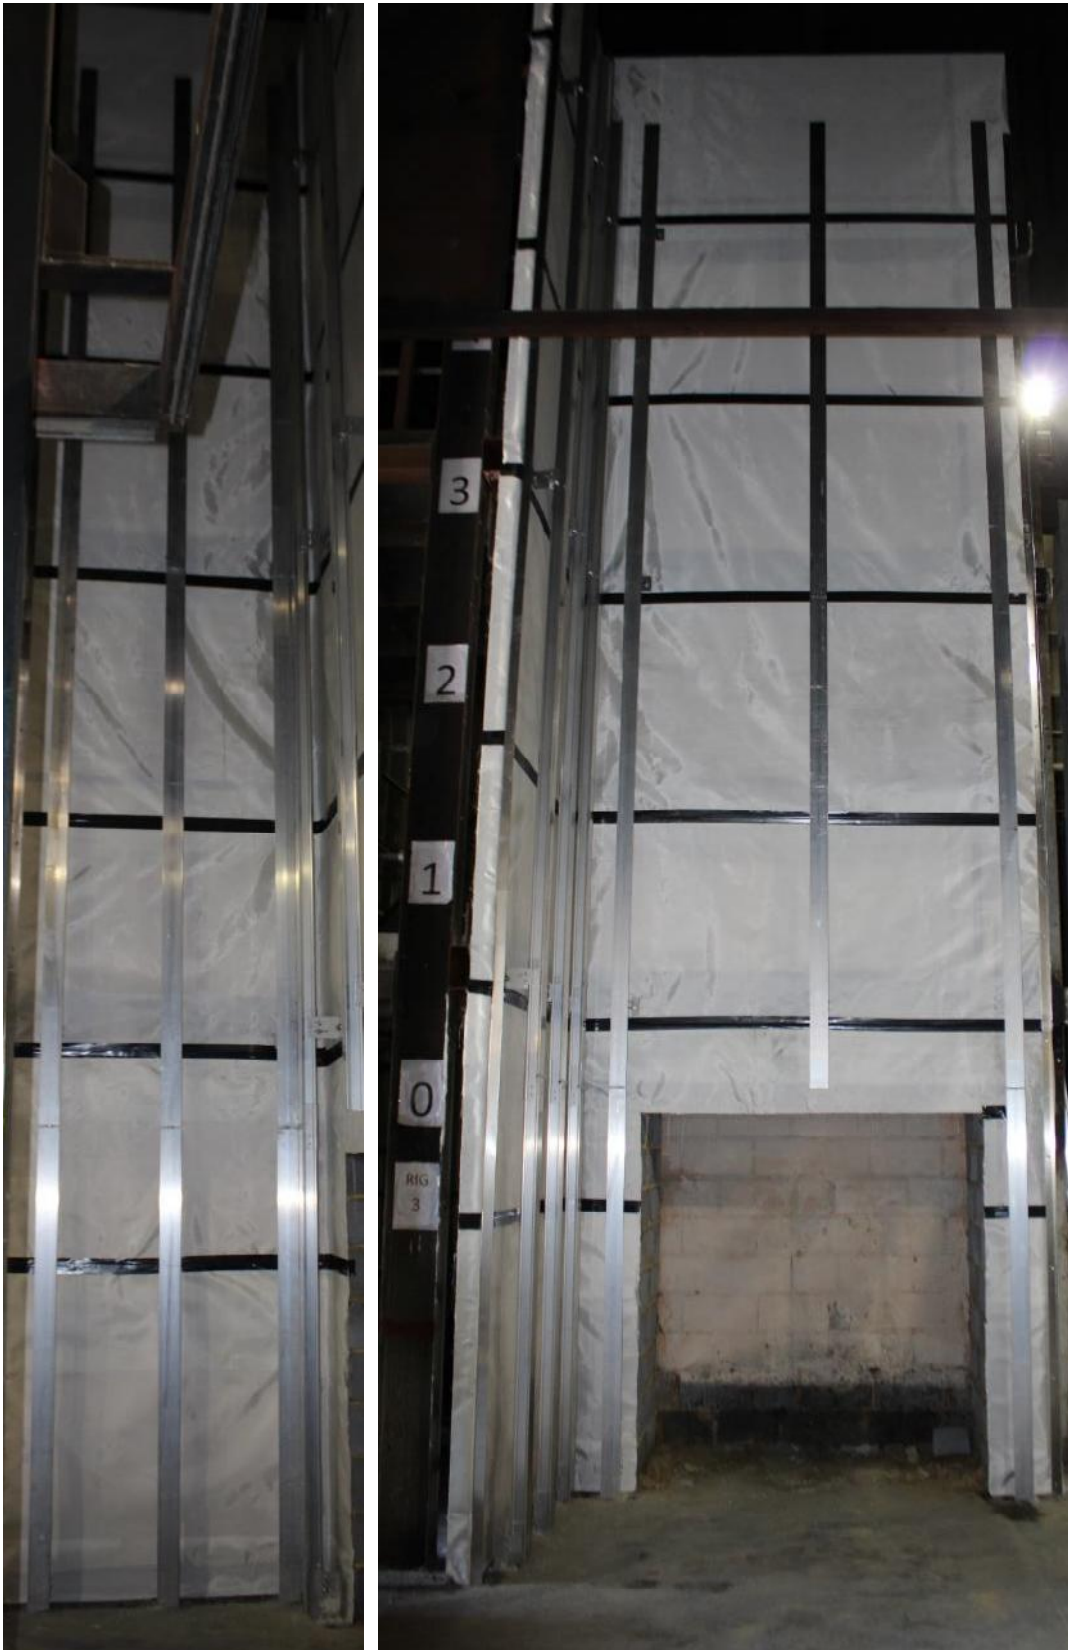
Figure 9. Aluminium 'L'-shaped brackets (Item 11A - left, Item 11B - right).

Aluminium brackets (Item 11A) were fixed to the SHS beams located at 2530mm, 5070mm and 7550mm from ground to underside of section, with one Lindapter M12 Holo-Bolt per bracket. Aluminium brackets (Item 11B) were fixed at the base of the system to the ground in line with the brackets fixed to the SHS beams, with two DEWALT DWT1400150 6.3mm×45mm screws per bracket. Horizontal bracket centres were 1064mm on the main wall and 568mm on the wing wall.

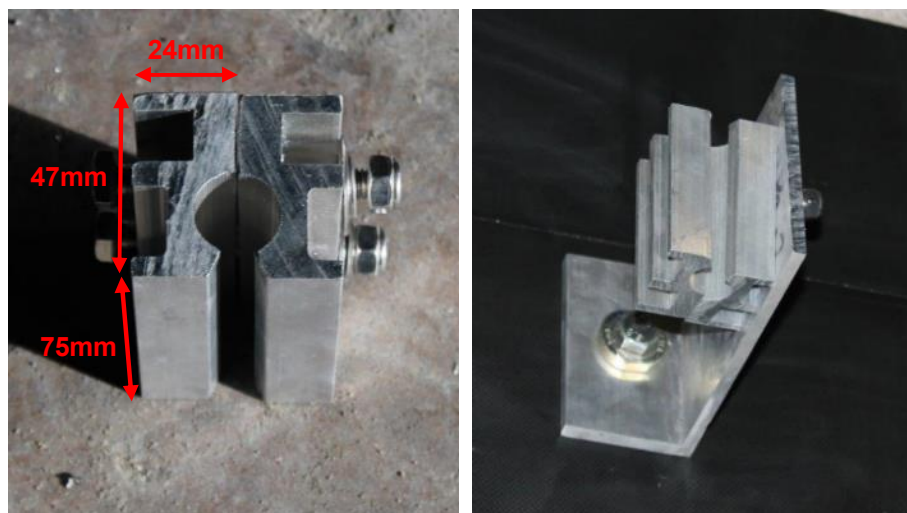
Figure 10. Profiled aluminium link blocks (Item 12).

Two aluminium link blocks (Item 12) were fixed back-to-back, 110mm from the sheathing board to the brackets with 2 × DIN933 A2 M8×60mm bolts, M8×25(×1.5) A2 penny washer, DIN 125-A A2 flat washer and DIN985 A2 M8 nut with nylon insert.

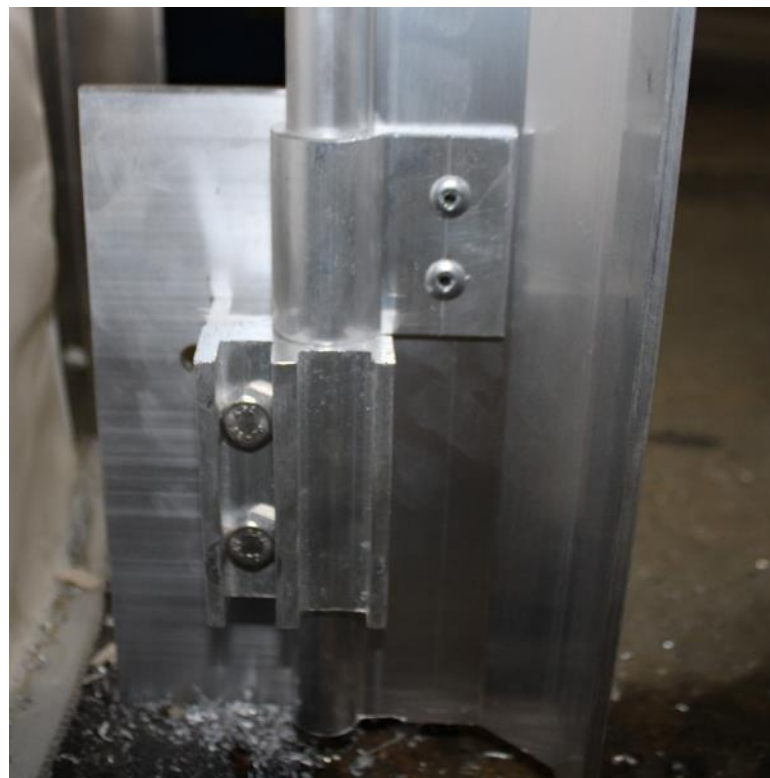
Figure 13. Aluminium dead load clip (Item 15).

Dead load clips (Item 15) were fixed to the web of the rails just above the link blocks (Item 12) at both locations (ground level and at 1st SHS) to secure rails in place. The dead load clips were fixed with two EasyFix 4.8mm × 14mm steel rivets per clip.

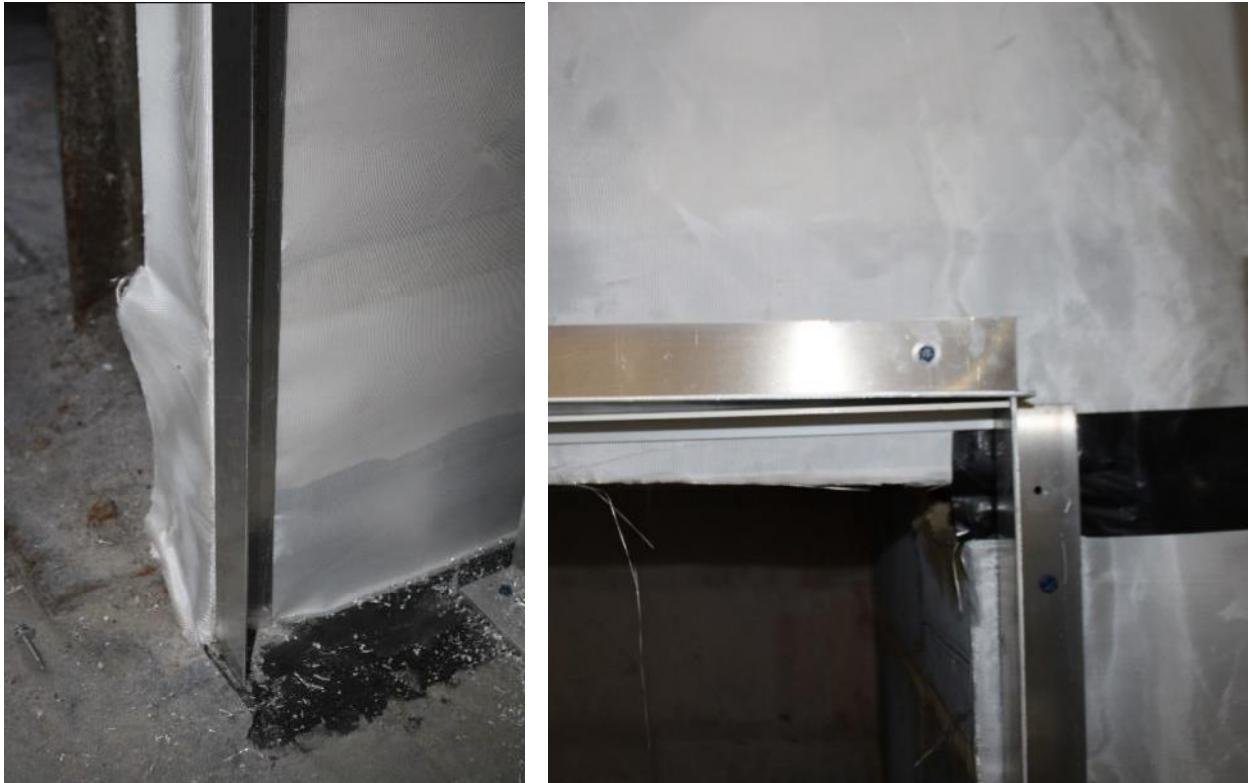
Figure 14. Aluminium 'L'-shaped angle.

Aluminium angle (Item 16) was fixed at the outer edges of the main and wing walls and around the combustion surround at the vertical (15mm offset) and horizontal (50mm offset) edges. The angles were fixed with DEWALT DWT1400150 6.3mm × 45mm screws at nominal 550mm centres.

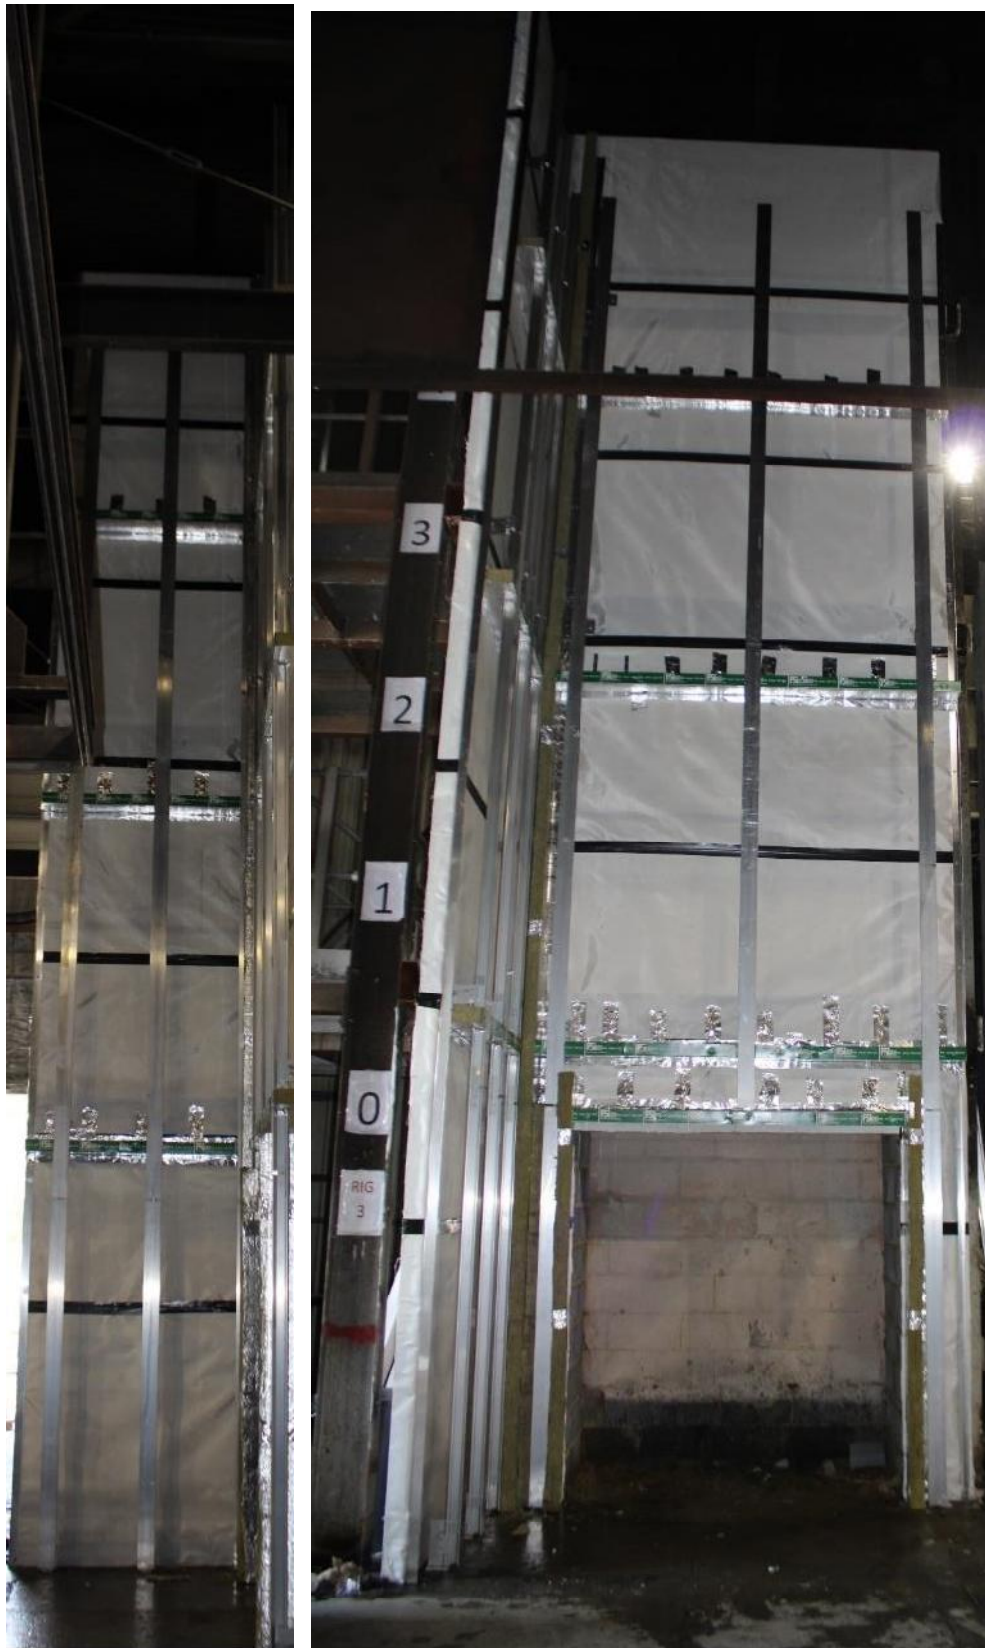
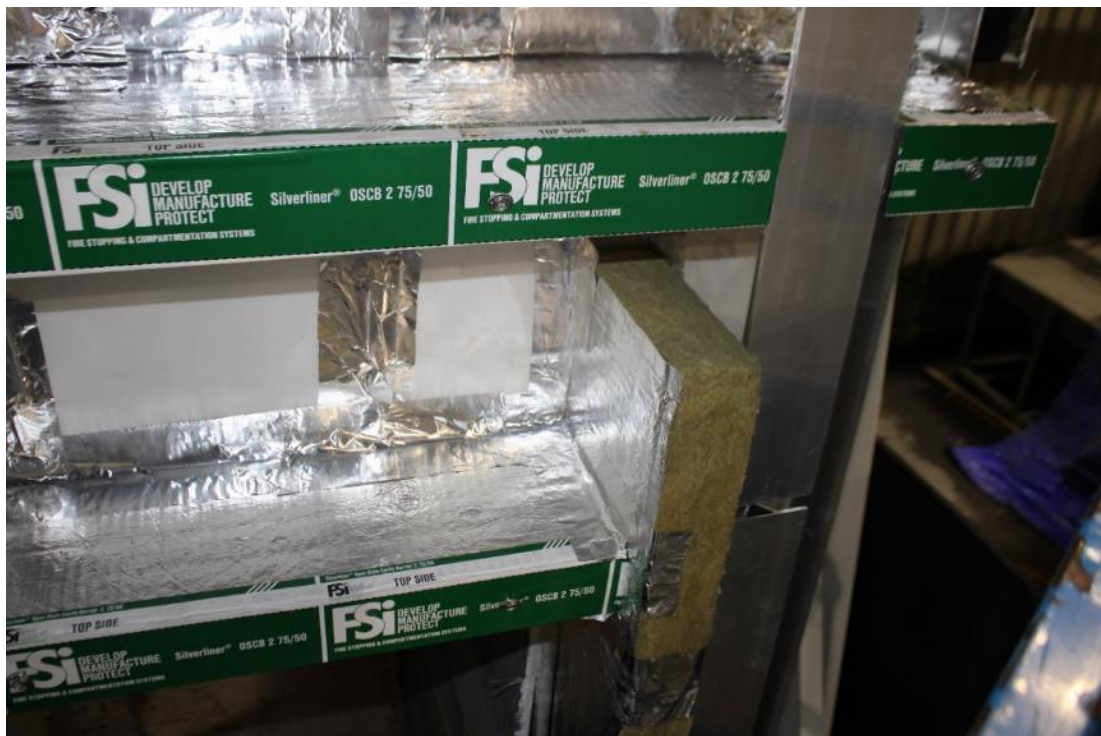
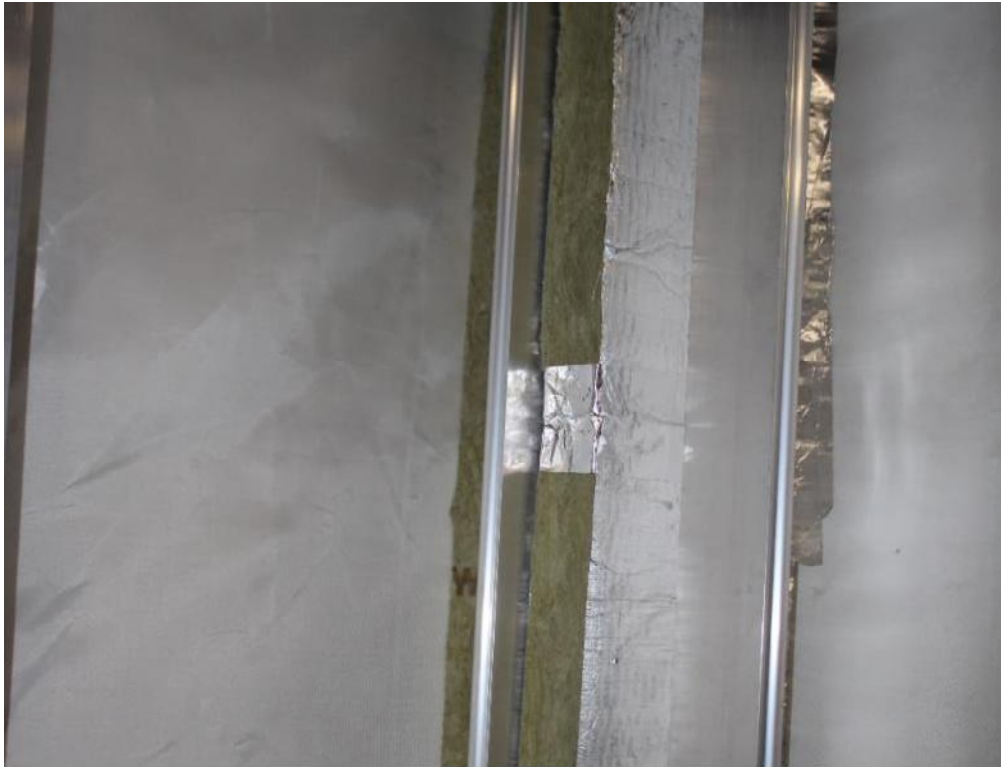
Figure 15. Installation of horizontal & vertical cavity barriers.

Steel split-end brackets (Item 17) were folded to 165mm-deep and fixed in three continuous rows located at: 2490mm, 4770mm and 6895mm from ground. Another row was located in line with the combustion chamber opening, 2127mm from ground. The brackets were fixed at 250mm horizontal centres with DEWALT DWT1400150 6.3mm×45mm screws to the combustion chamber blockwork and Evolution TSBW5.5-38-3 (5.5mm×38mm) screws (with EPDM washer) to the sheathing board, two fixings per brackets.

Horizontal cavity barriers (Item 18) were pressed onto the split-end brackets in rows and notched around the 'T'-shaped rails, with a section of the intumescent strip removed in line with the width of the 'T'-shaped rails. Aluminium tape was applied to: barrier-barrier joints (top and bottom face), sheathing board-barrier joints and barrier-'T'-shaped rail joints.

Steel brackets (Item 19) were folded to 170mm-deep and fixed in one continuous column located at: 230mm from the wing wall breather membrane face. Two other columns were located either side of the combustion chamber at: 470mm and 2455mm from the wing wall sheathing board to a height of 2400mm. The brackets were fixed at 250mm vertical centres with DEWALT DWT1400150 6.3mm×45mm screws to the combustion chamber blockwork and Evolution TSBW5.5-38-3 (5.5mm×38mm) screws with EPDM washers to the sheathing board, two fixings per brackets.

Vertical cavity barriers (Item 20) were pressed onto the brackets in columns. Aluminium tape was applied: to barrier-sheathing board joints, at vertical barrier-horizontal barrier joints (top and bottom face of horizontal barrier) and vertical barrier-barrier joints (front and side face).

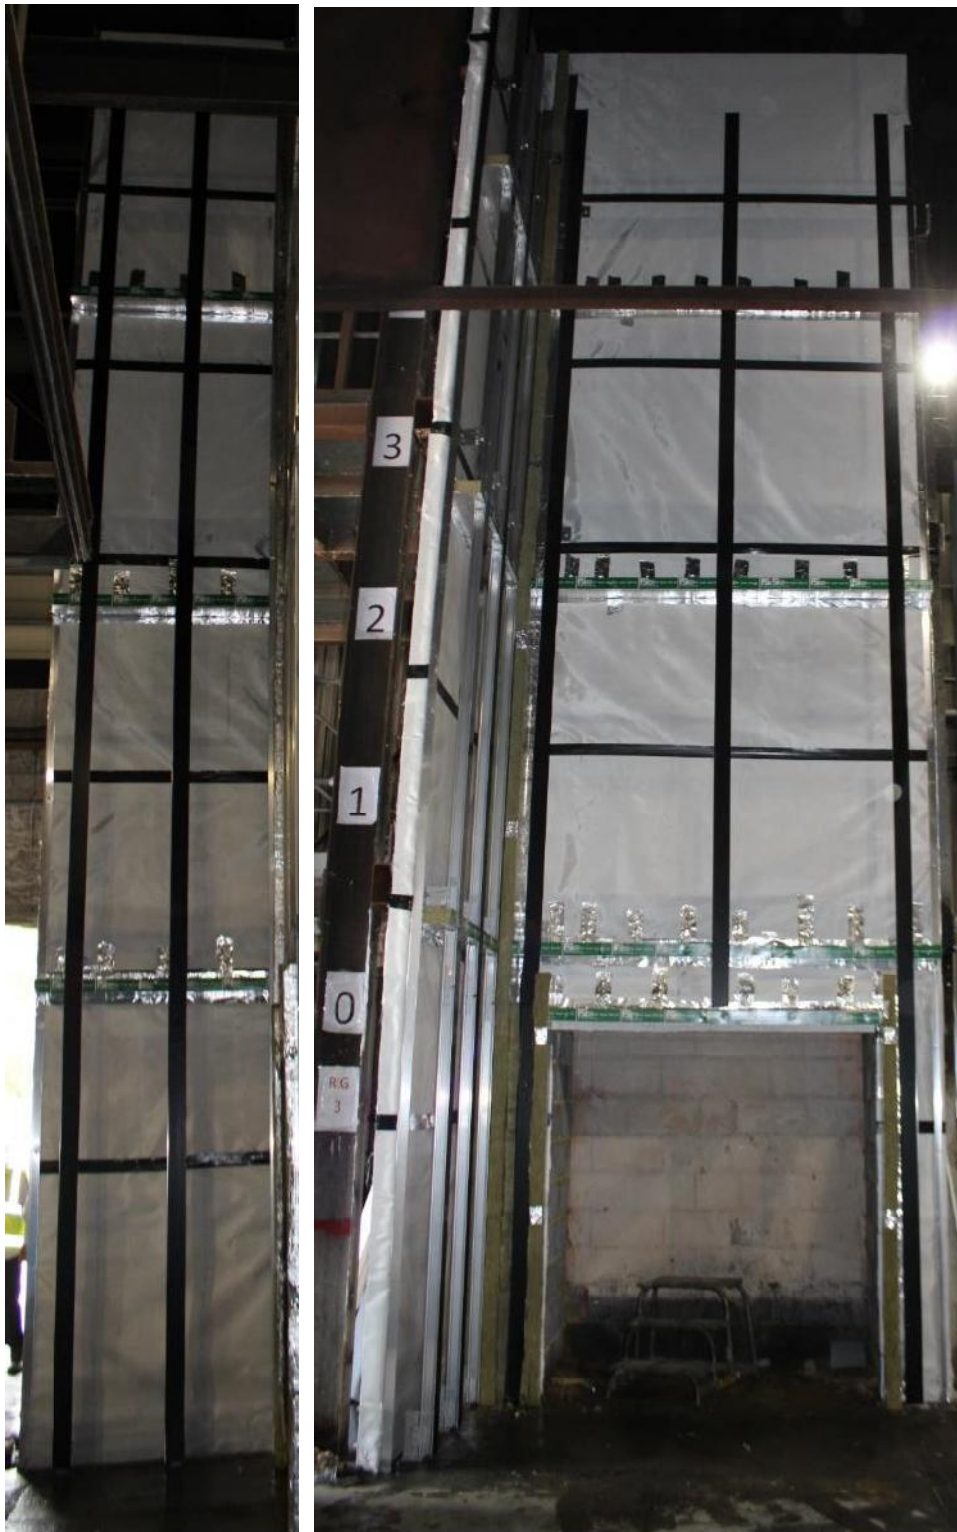
Figure 19. Installation of tape to profiled 'T'-rail face.

Cortex UV Façade Tape (Item 10) was applied to the face of the 'T'-shaped rails vertically from ground to full height of system.

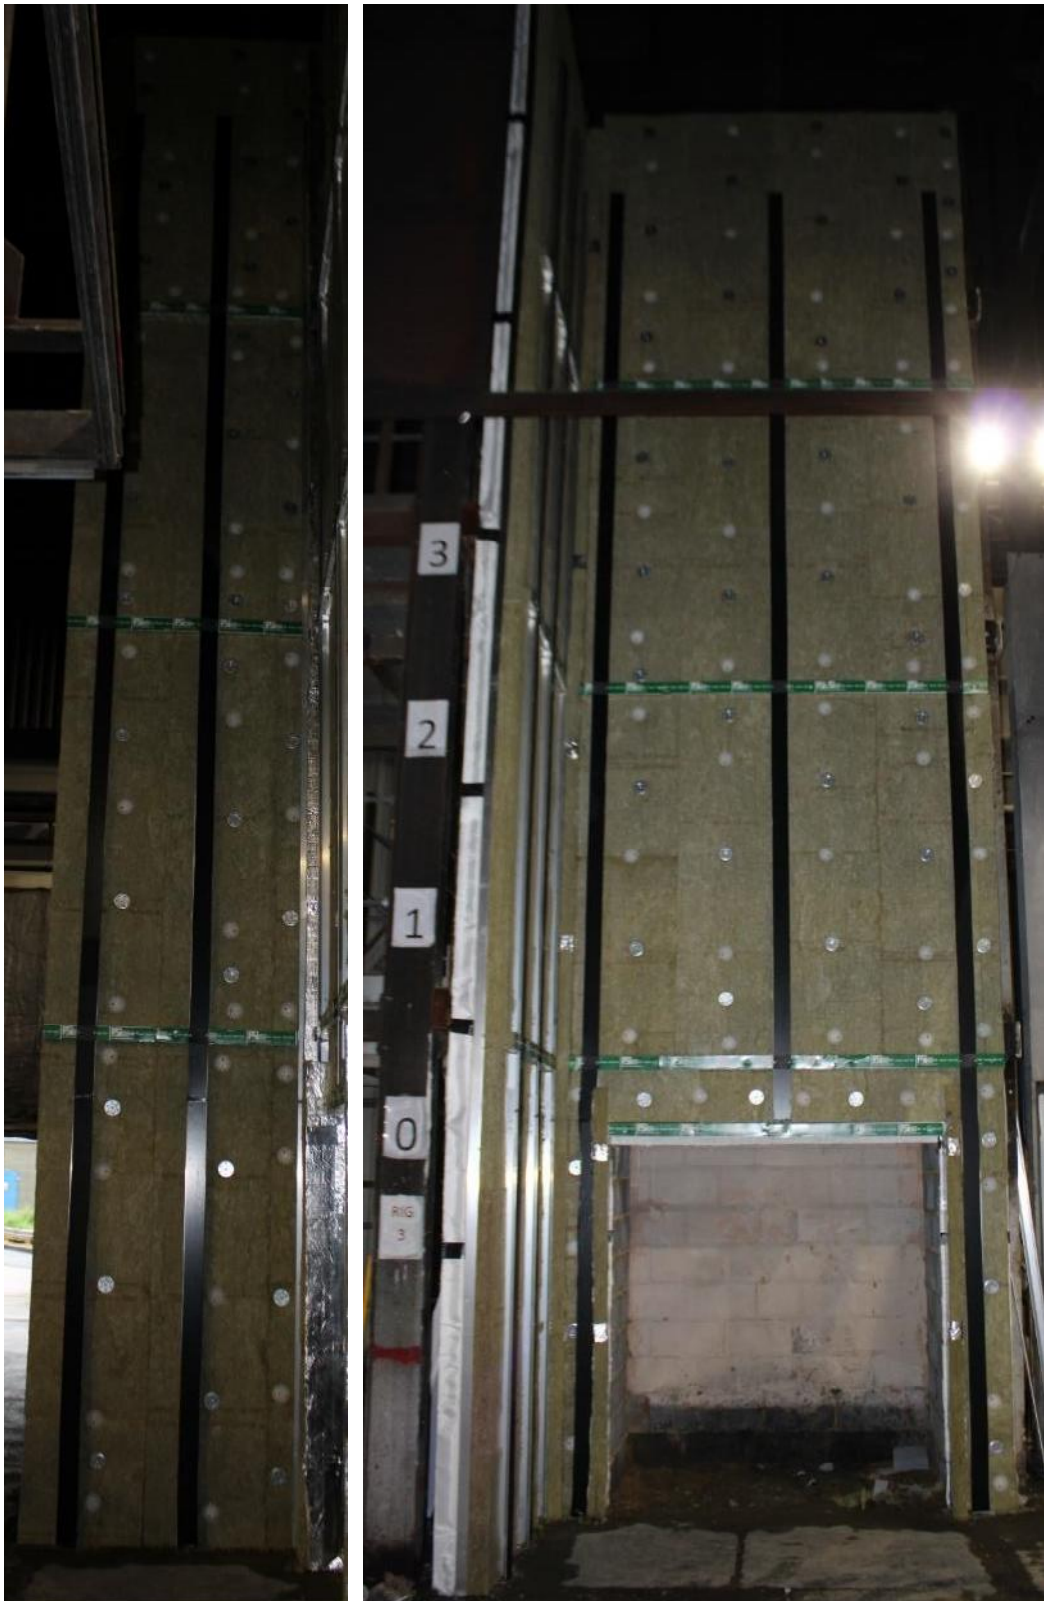
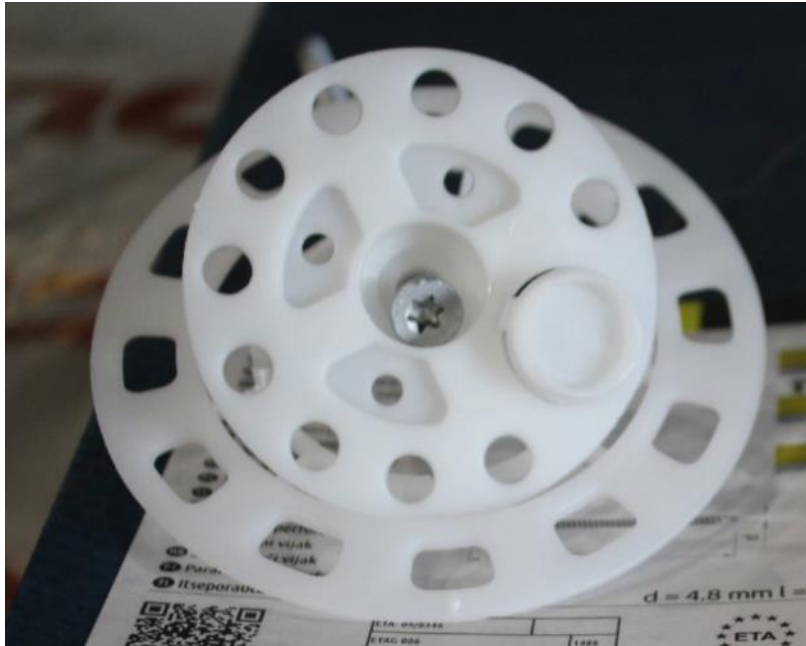
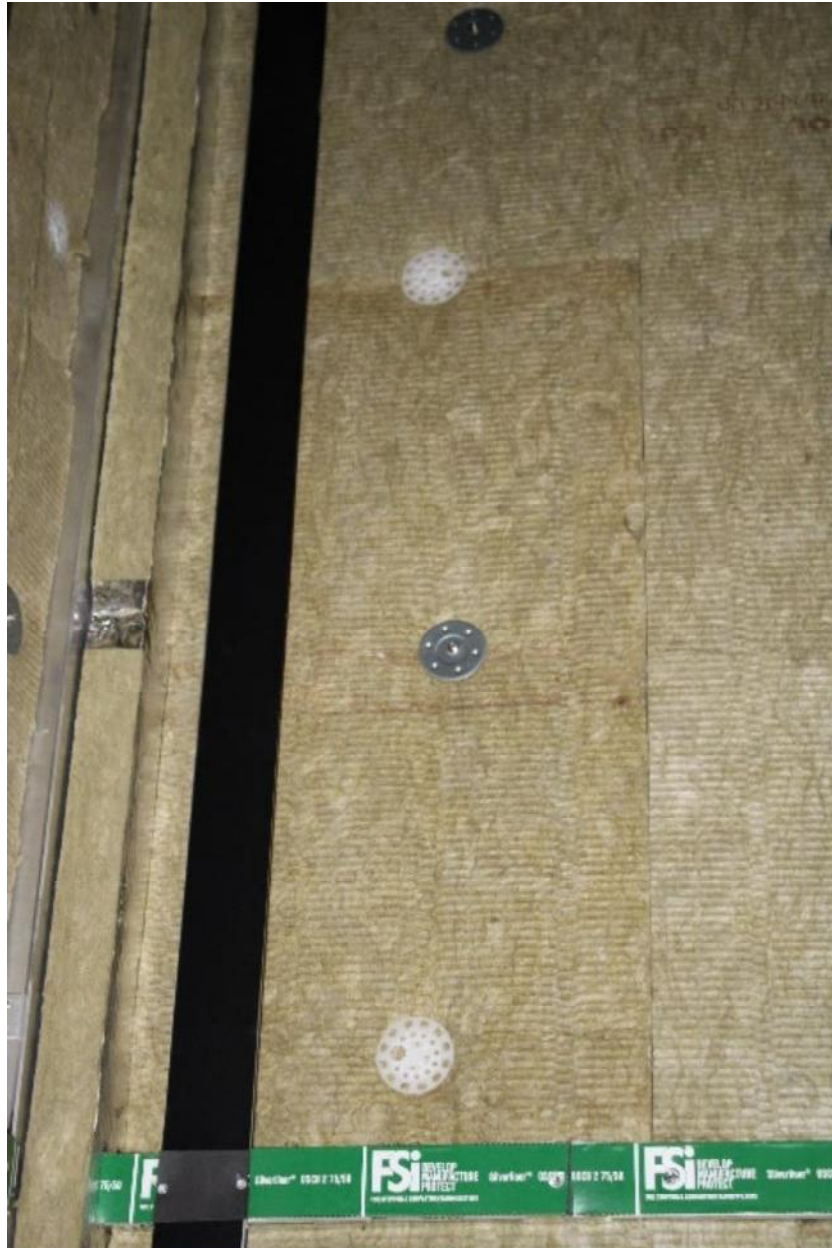
Figure 20. Installation of the insulation & and intumescent strip.

Insulation slabs (Item 21) were fixed (long edge vertical) with staggered horizontal joints. The insulation was fixed with screws and insulation washers:

- Rawplug OCS-55/63170 6.3mm×170mm screws with Rawlplug MKC-85 (Ø85mm) metal washer (at the centre of the slab), or
- Rawplug R-WX-48T180 4.8mm×180mm screws with Koelner Ø90mm plastic (outer) washer and Rawlplug R-KC (Ø60mm) plastic (inner) washer (between adjoining slabs at mid-width).

There was an 45mm cavity from the front face of the insulation to the front face of the 'T'-rail.

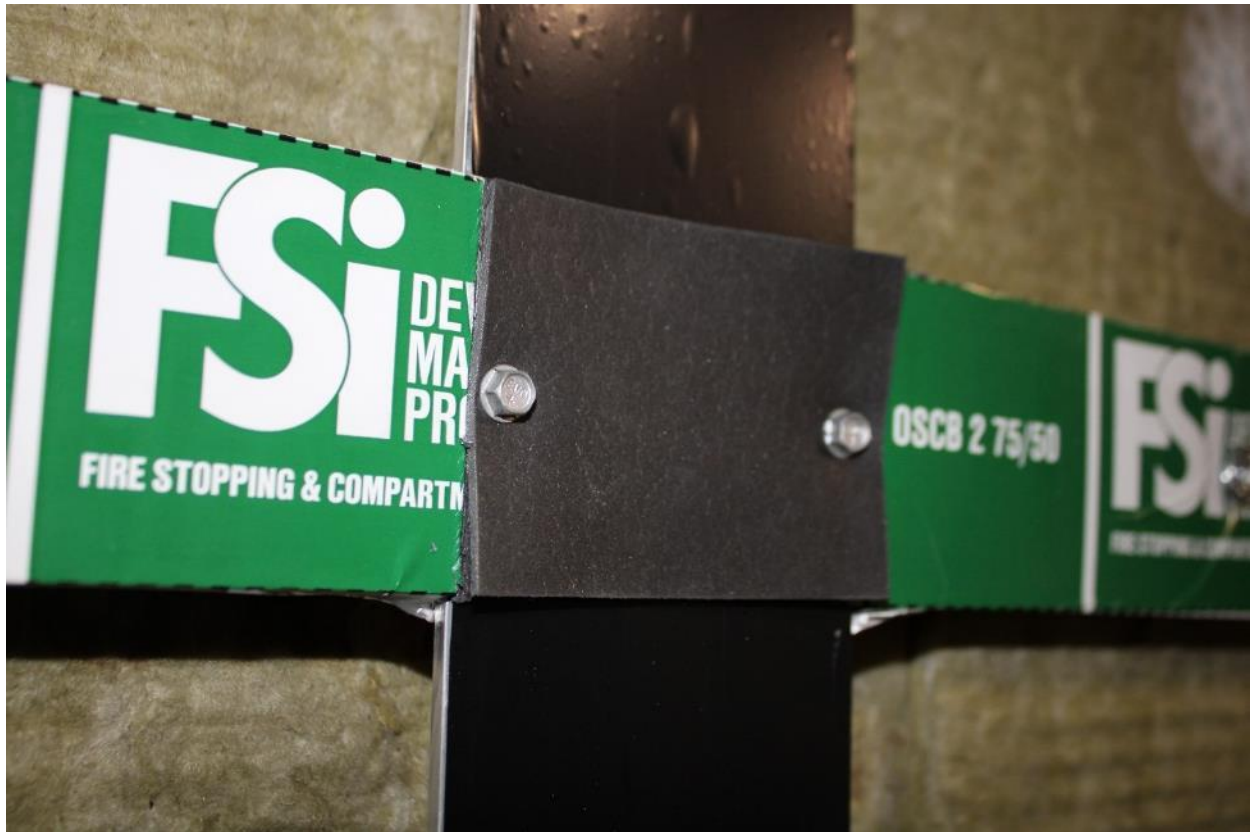
Figure 24. Intumescent strip applied to face of rail.

Intumescent strip (Item 22) was fixed to the 'T'-shaped rails at the horizontal barrier heights, where a section of intumescent had been removed. The intumescent strip was double lapped and fixed with two Evolution TSBW5.5-38-3 (5.5mm×38mm) screws, nominal 85mm apart.

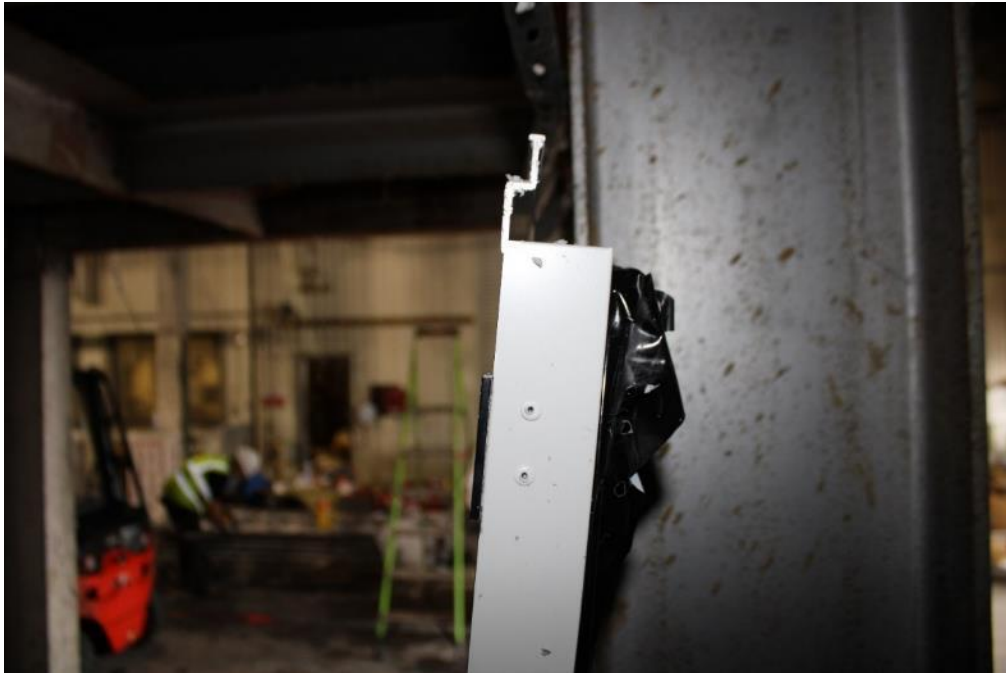
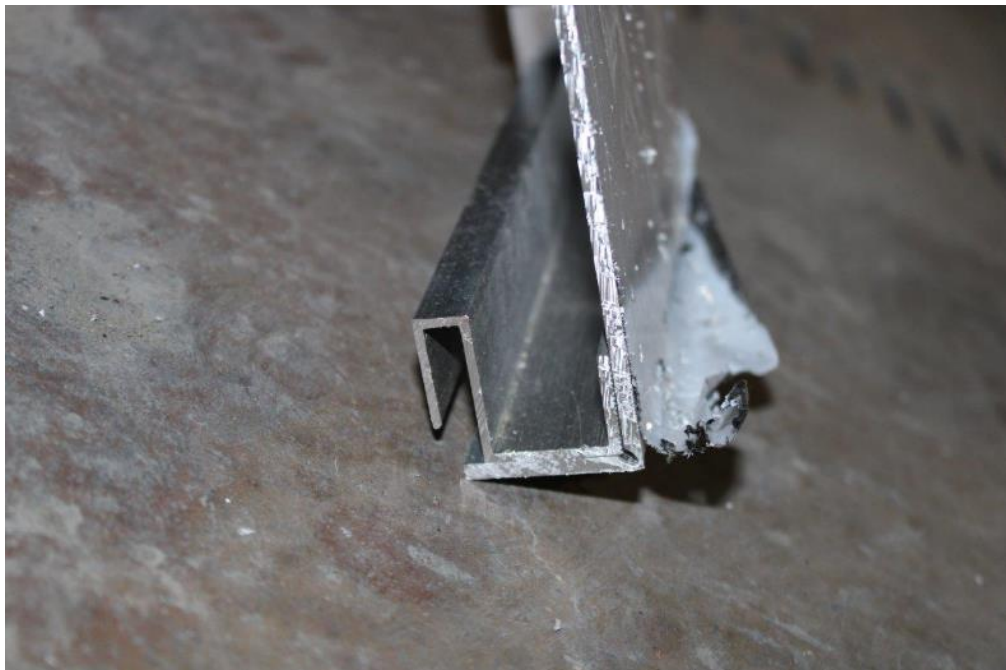
The cassette panels (Item 24) had a 40mm-deep profile with a 45mm-high lip at the top of each panel and a profile at the base of each panel to allow panels to be slotted into position.
