BRE Global Test Report

BS 8414-2:2015 + A1:2017 Test on 3mm-thick aluminium cassette panels with 150mm-thick Rockwool Rainscreen Duo Slab insulation

Prepared for: SBS Cladding

Report Number: P119916-1000 Issue: 2

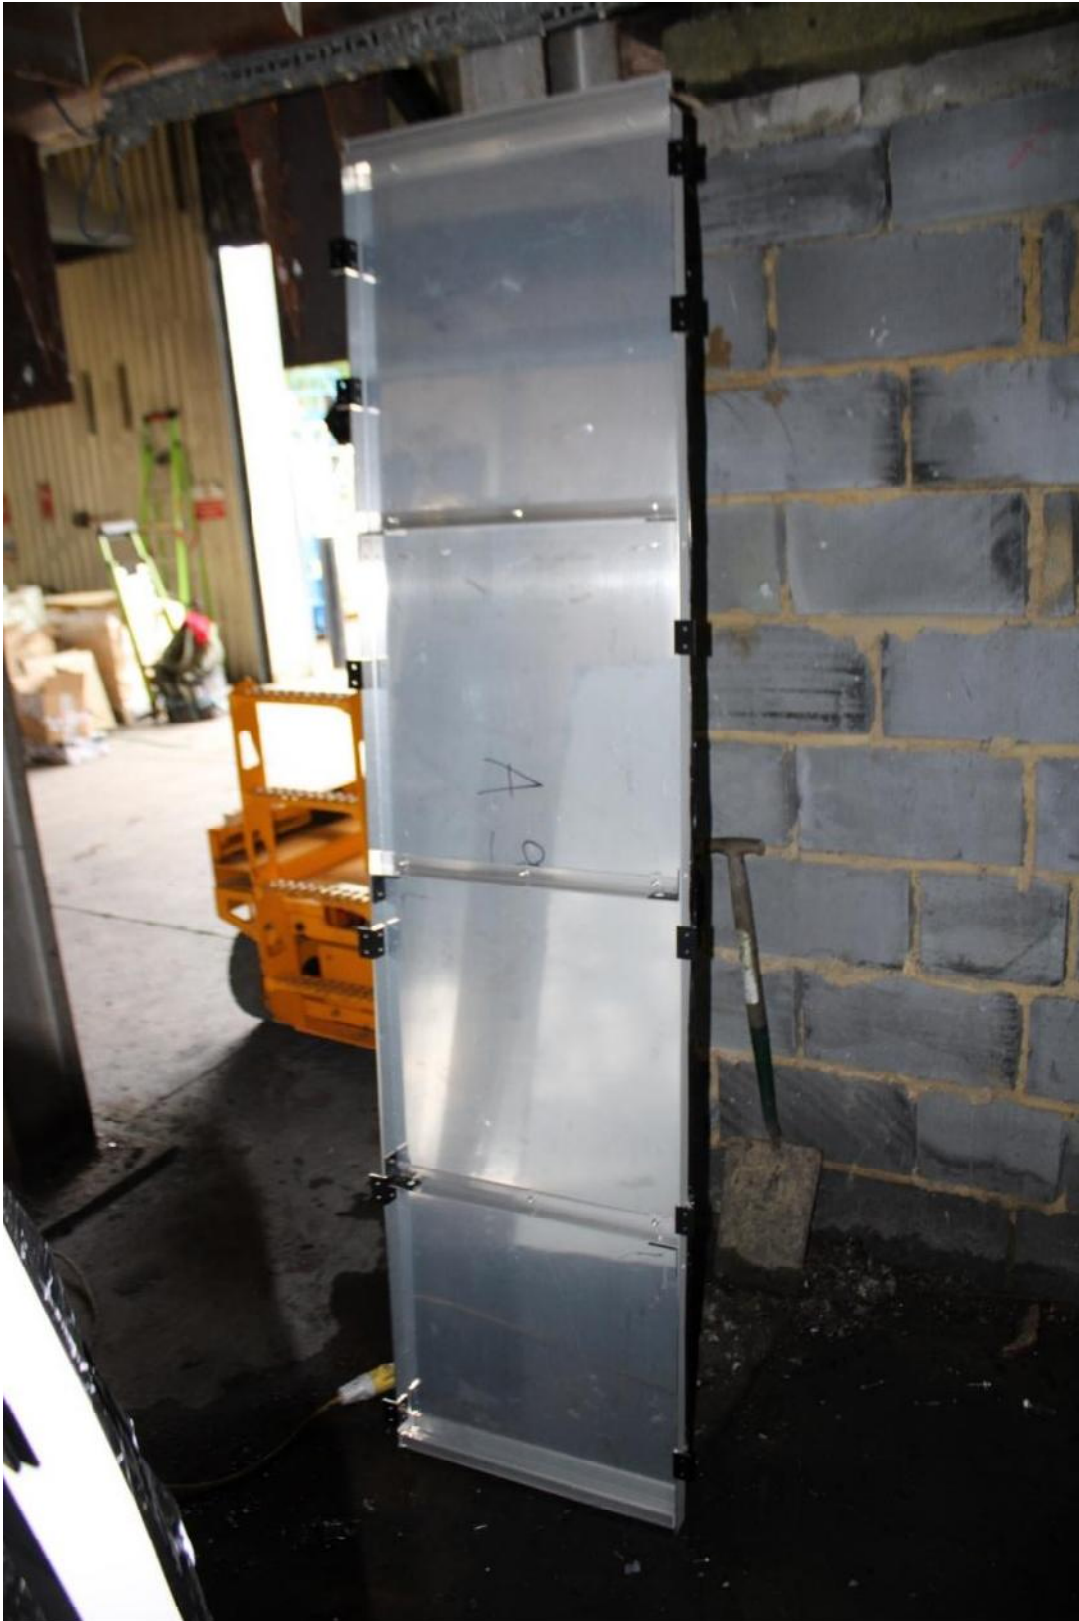
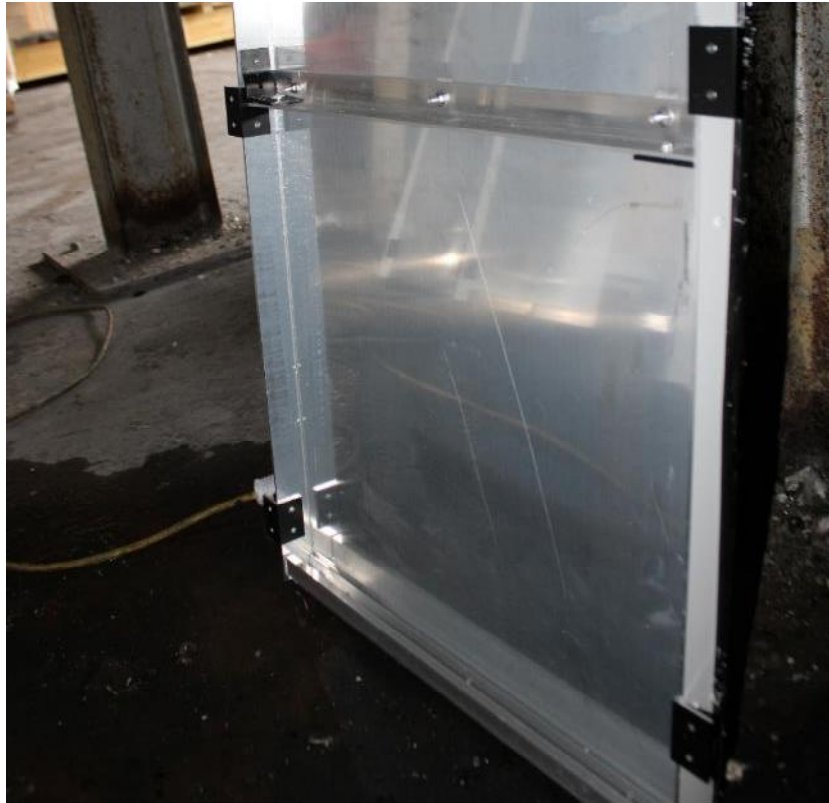
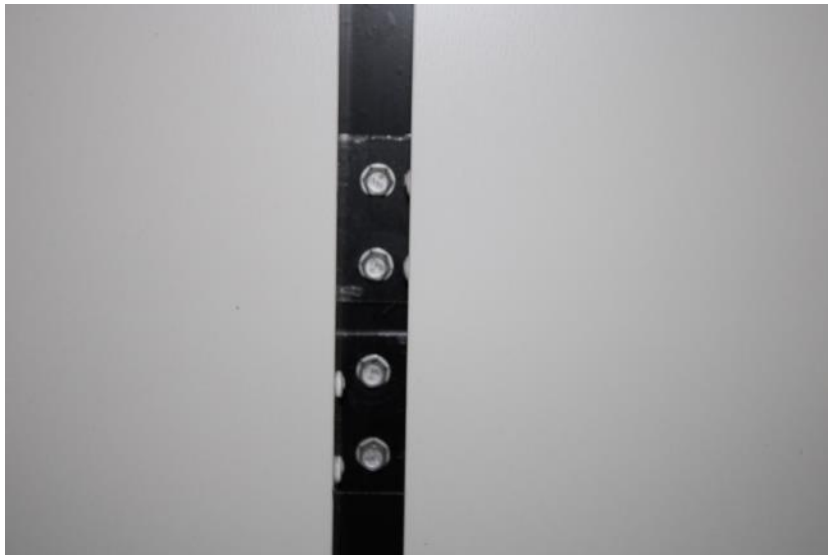
All panels had fixing location brackets prefabricated at 450mm vertical centres. The fixing brackets of the panels were fixed to the 'T-shaped rails with two Evolution TSBW5.5-38-3 (5.5mm×38mm) screws per bracket.

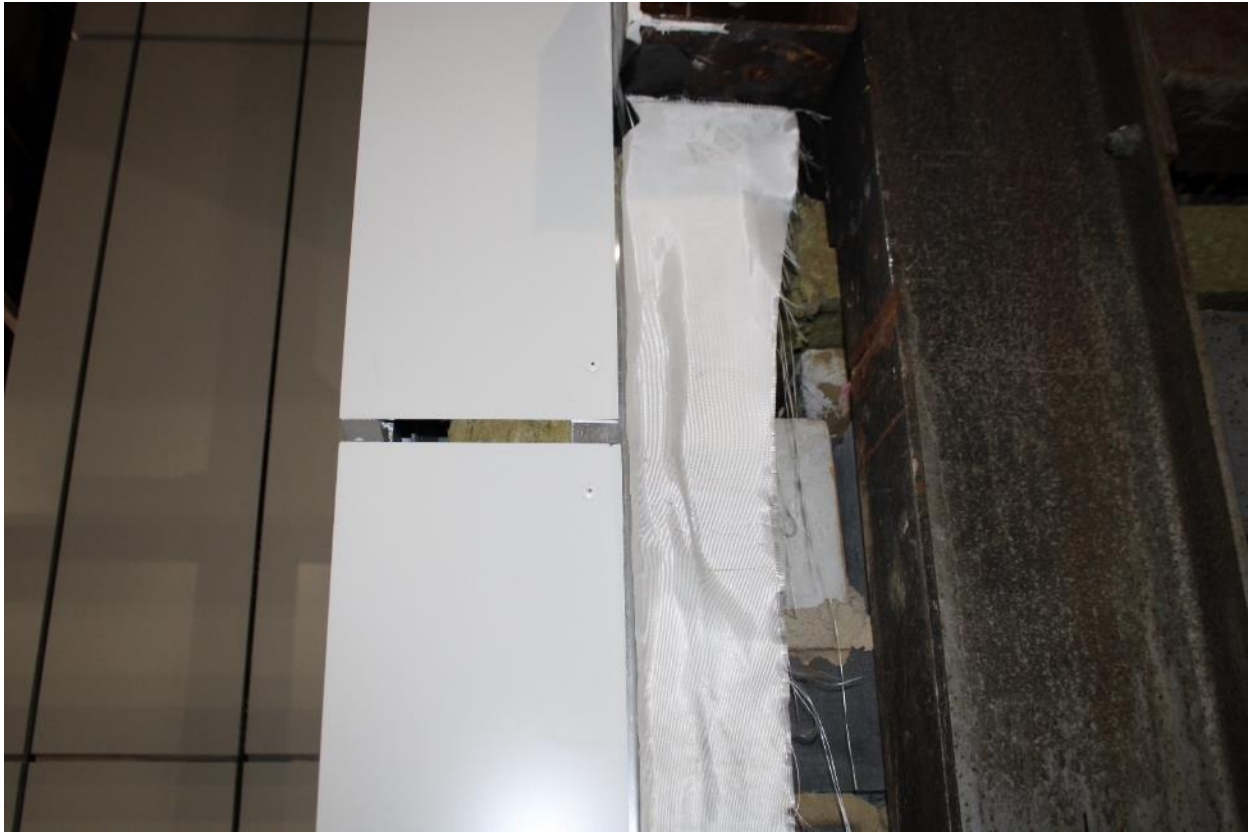
Figure 32. Edge of walls side panel profile.

The panels in line with the outside edge of the main and wing walls had a 230mm panel return to close the sides of the system off. The panel returns at outside edge of main and wing wall were fixed to the side of the system with Mainline SSAL/501214AS/RA_9010 5.0×12×14mm AlMg5/stainless steel rivets at nominal 400mm vertical centres.

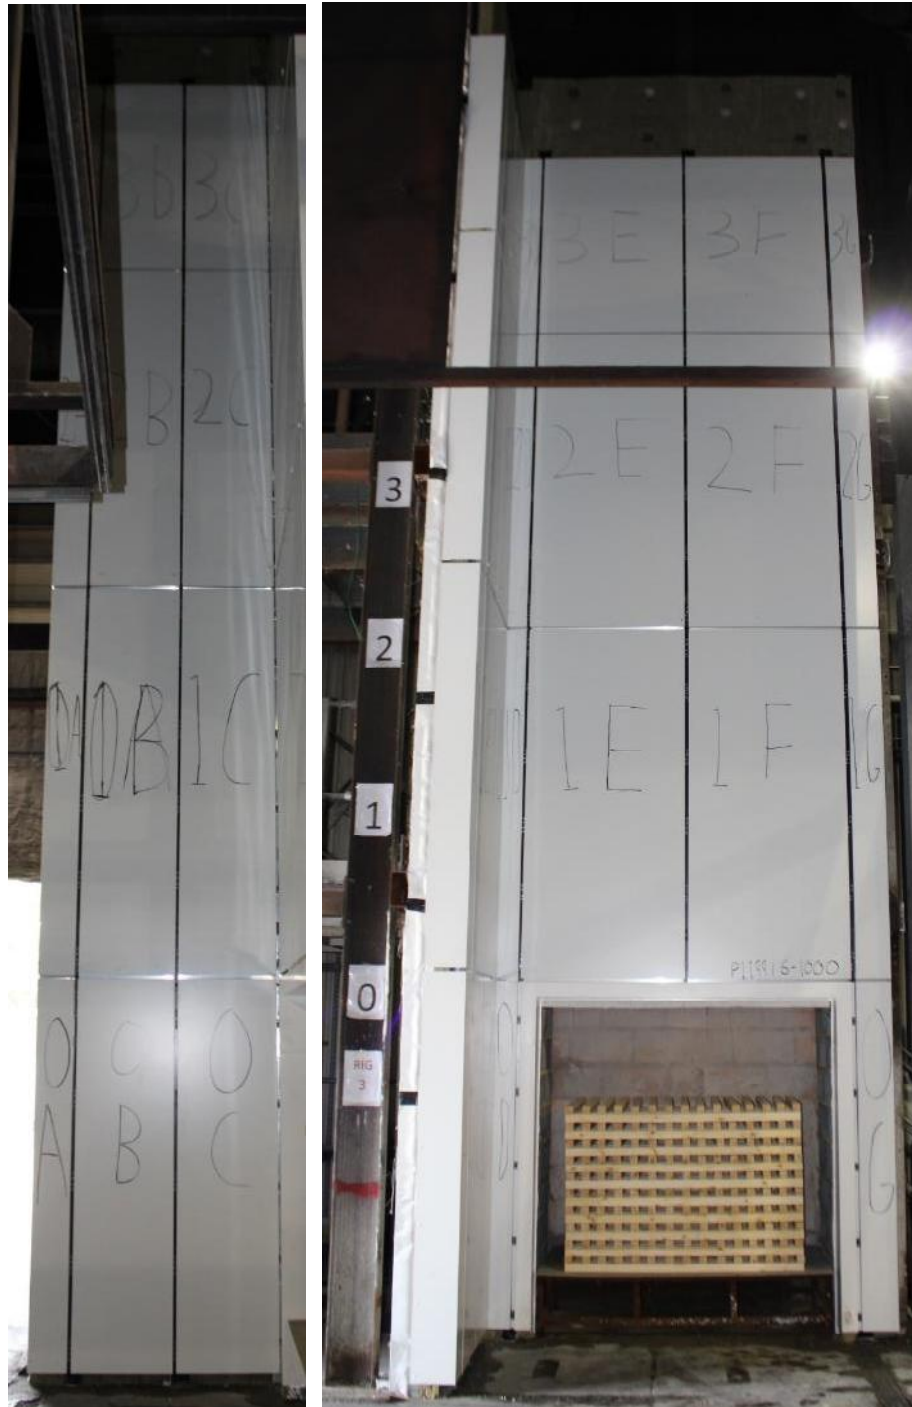
Figure 33. Completed installation prior to test.

The bottom edge of the first row of panels was located approximately 70mm above the ground. Panel gaps were measured to be 20mm vertical and horizontal gaps. Between the combustion chamber flashing and panels, the gaps were approximately 28mm.

There was an 85mm cavity (including 40mm panel profile) from the front face of the insulation to the rear face of the panel. There was a 45mm cavity from the front face of the horizontal cavity barrier to the rear face of the panel.

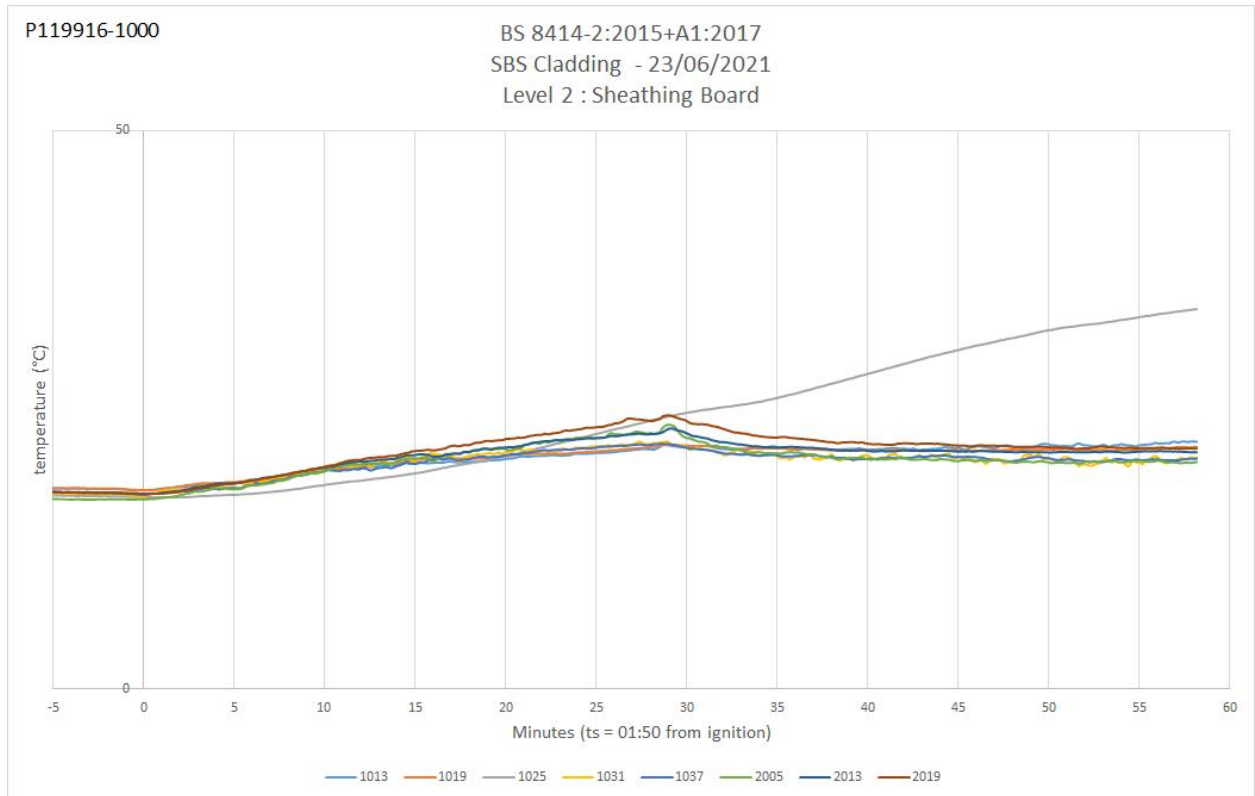
Figures 44-50 provide the temperature profiles recorded during the test. Figure 33 shows the system before the test.

Thermocouple set	Whole test	t_s + 15mins
Max Level 1: External	860°C (1003 @ t_s + 04:50)	-
Max Level 2: External	450°C (1021 @ t_s + 04:50)	450°C (1021 @ t_s + 04:50)
Max Level 2: Panel cavity	335°C (1039 @ t_s + 07:10)	335°C (1039 @ t_s + 07:10)
Max Level 2: Cavity	325°C (1017 @ t_s + 07:10)	325°C (1017 @ t_s + 07:10)
Max Level 2: Insulation	41°C (1018 @ t_s + 42:10)	29°C (1018 @ t_s + 15:00)
Max Level 2: Sheathing board	34°C (1025 @ t_s + 58:10)	21°C (2019 @ t_s + 14:50)
Max Level 2: Steel Framing System	26°C (2020 @ t_s + 28:40)	23°C (2020 @ t_s + 14:40)

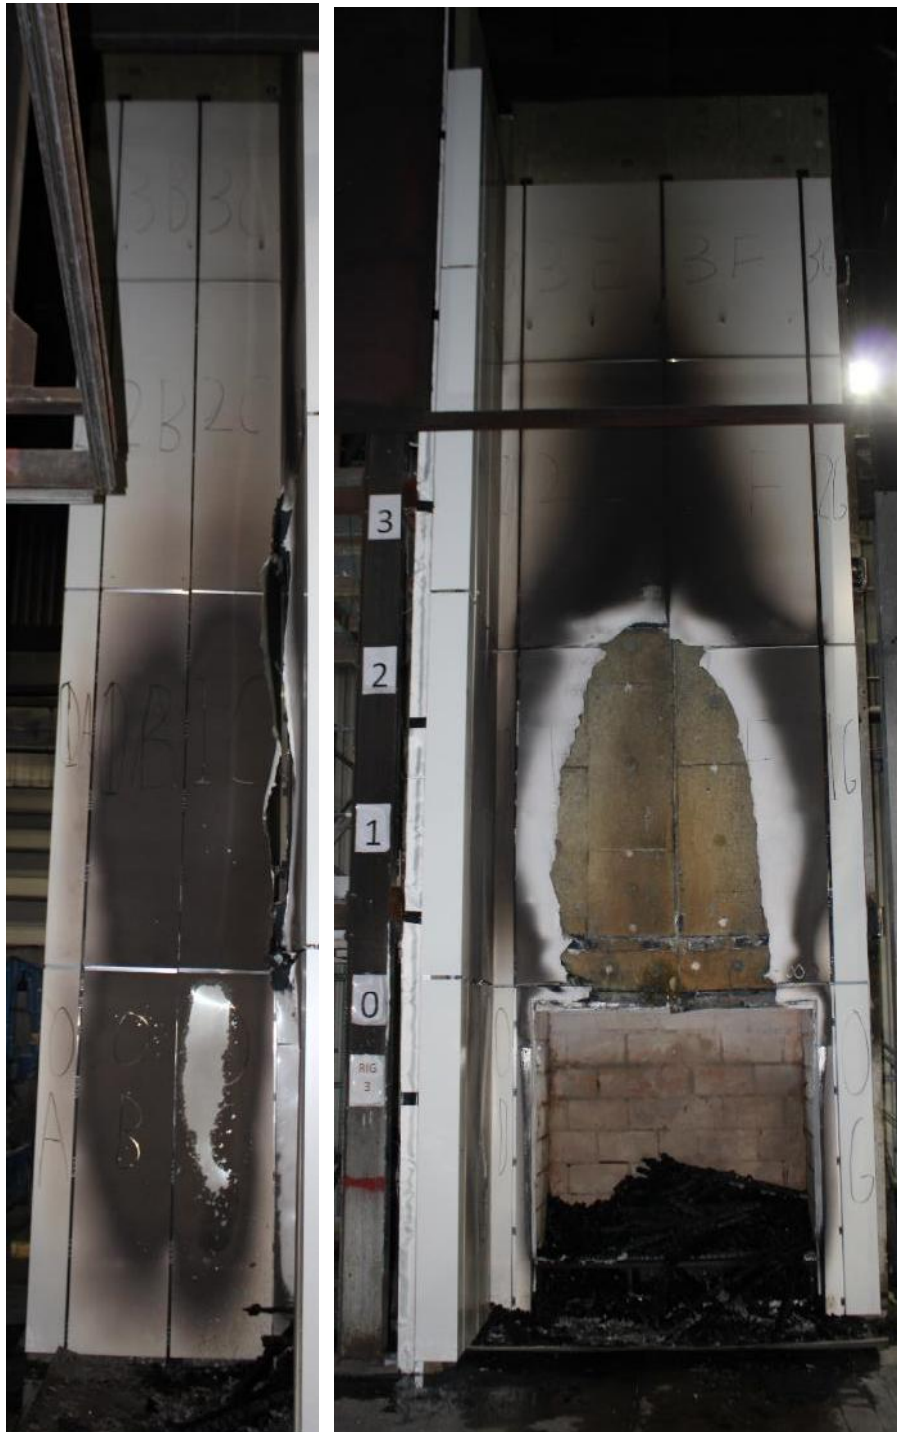
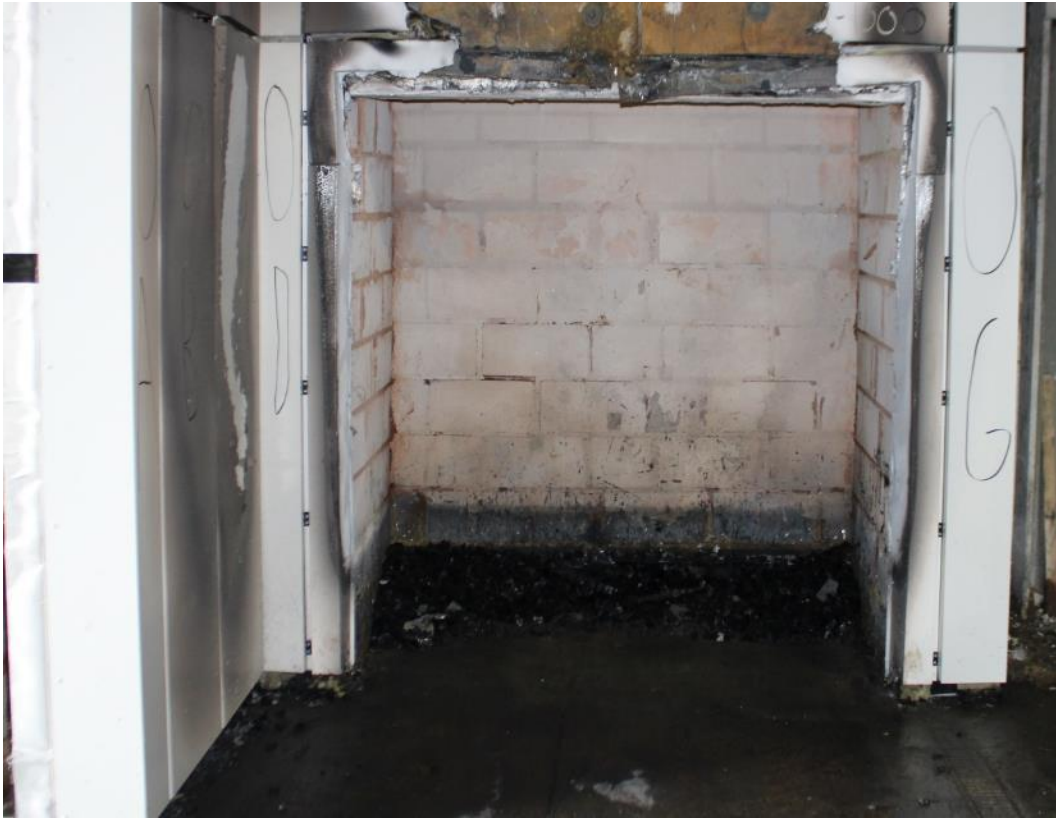
On the main wall, the panels were melted in an area of approximately 2600mm-high \times 1360mm-wide (max) tapering to 500mm-wide (approx. $3.6m^2$), directly above the combustion chamber opening. All main wall panels were distorted up to the base of panels 3E & 3F and discoloured to top of system.

On the wing wall, the panels were distorted up to the base of panels 2B & 2C and discoloured to mid-height of panel 2C.

The combustion chamber flashing was melted to approx. 1360mm-wide along the top edge, with a melted patch at the top of each vertical edge.

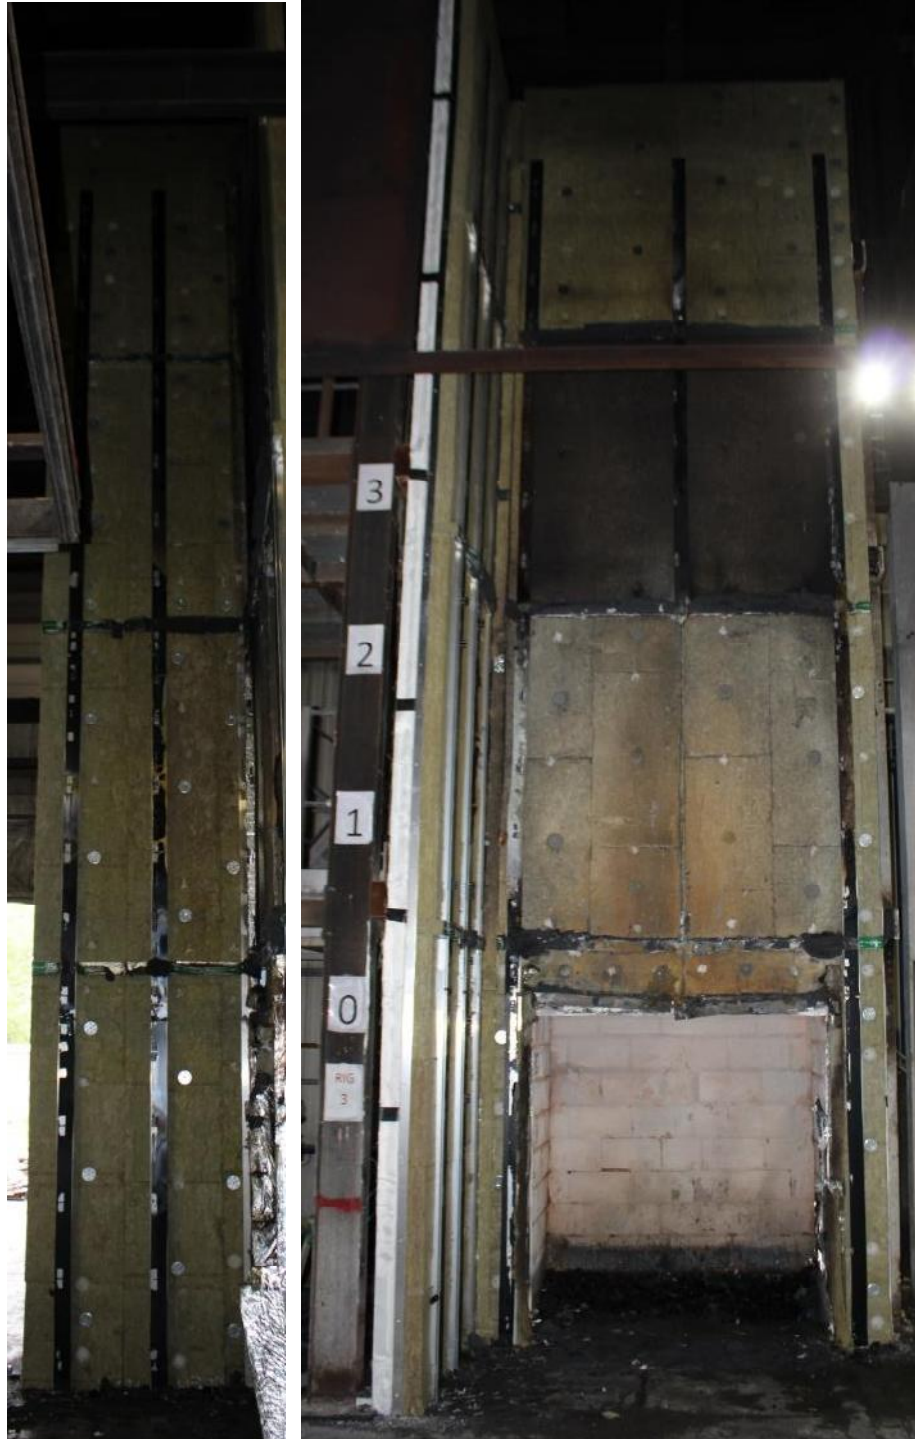
Figure 53. Full-height photograph following removal of panels.

On the main wall, the insulation remained in place and was discoloured up to 5300mm from above the combustion chamber opening.

On the wing wall, the insulation had discoloured patches between 2500mm-5000mm from ground.

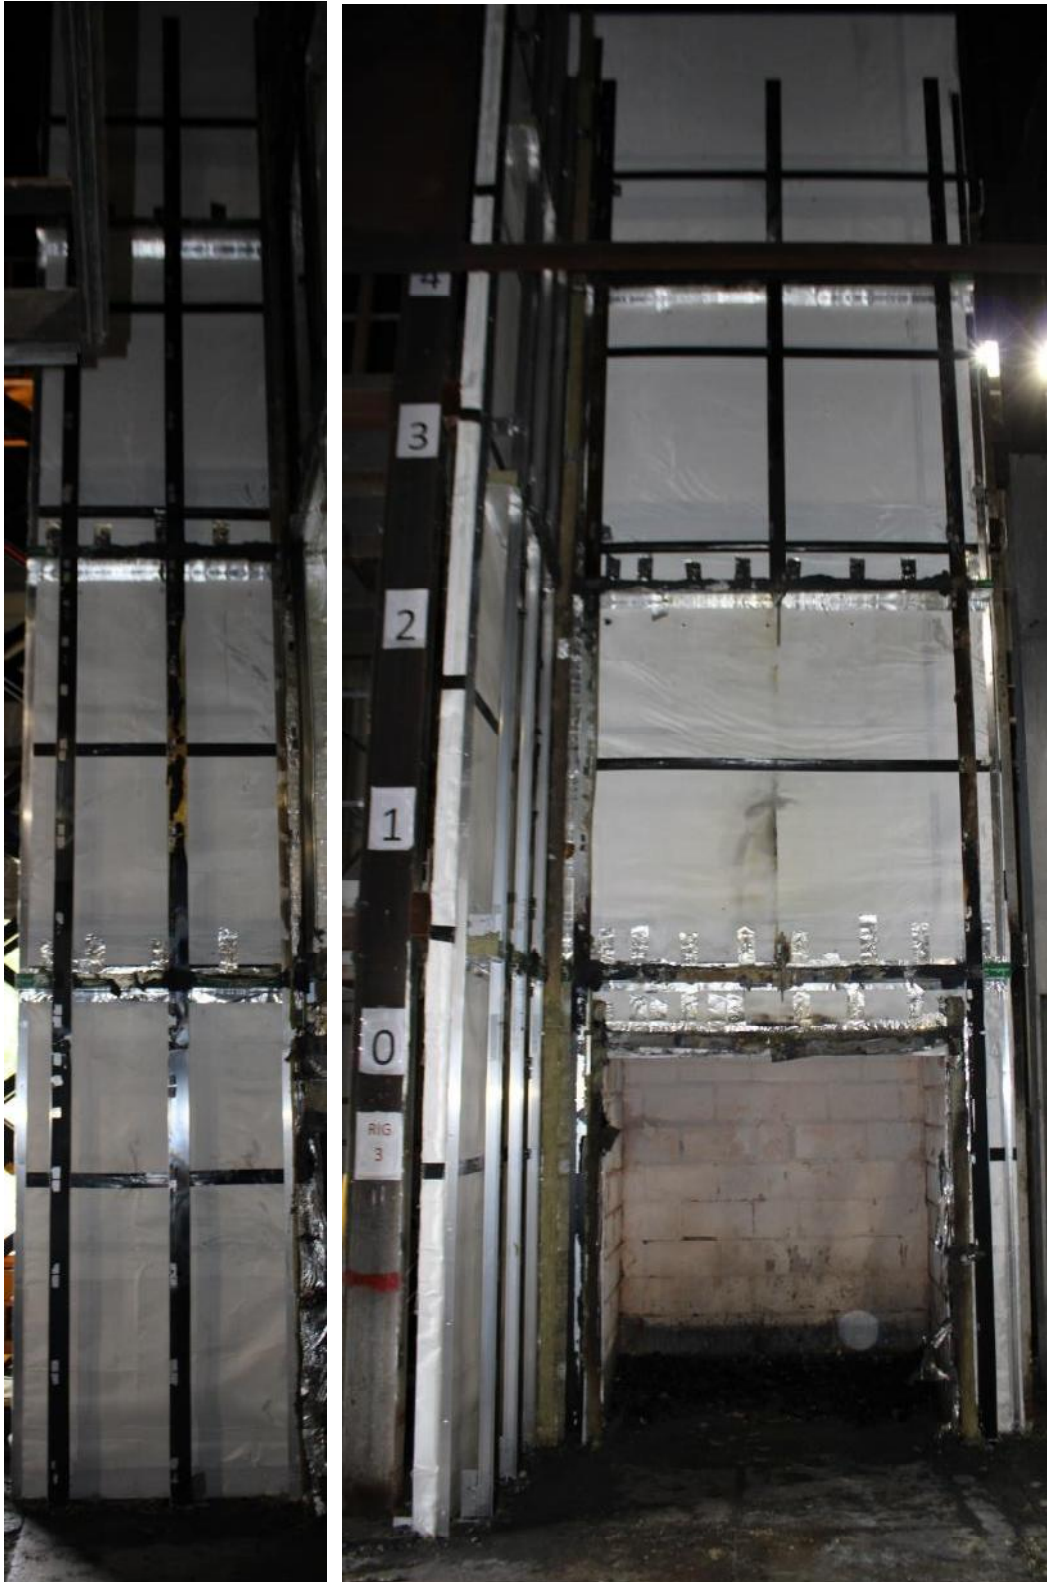
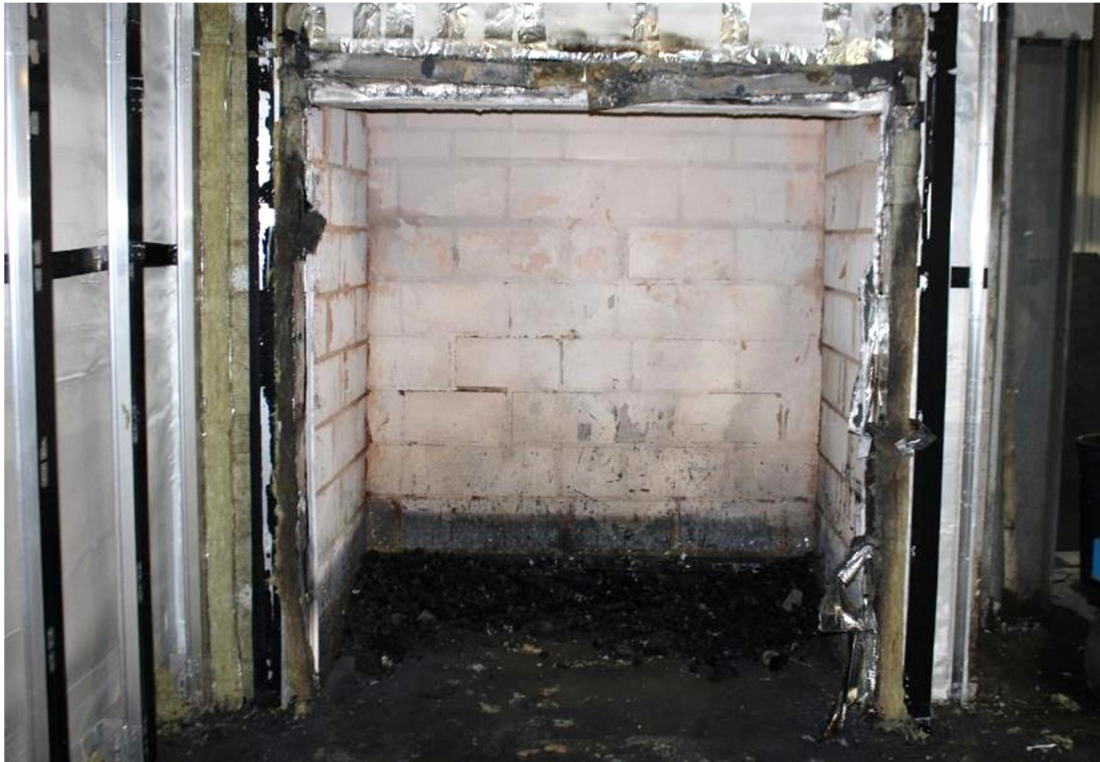
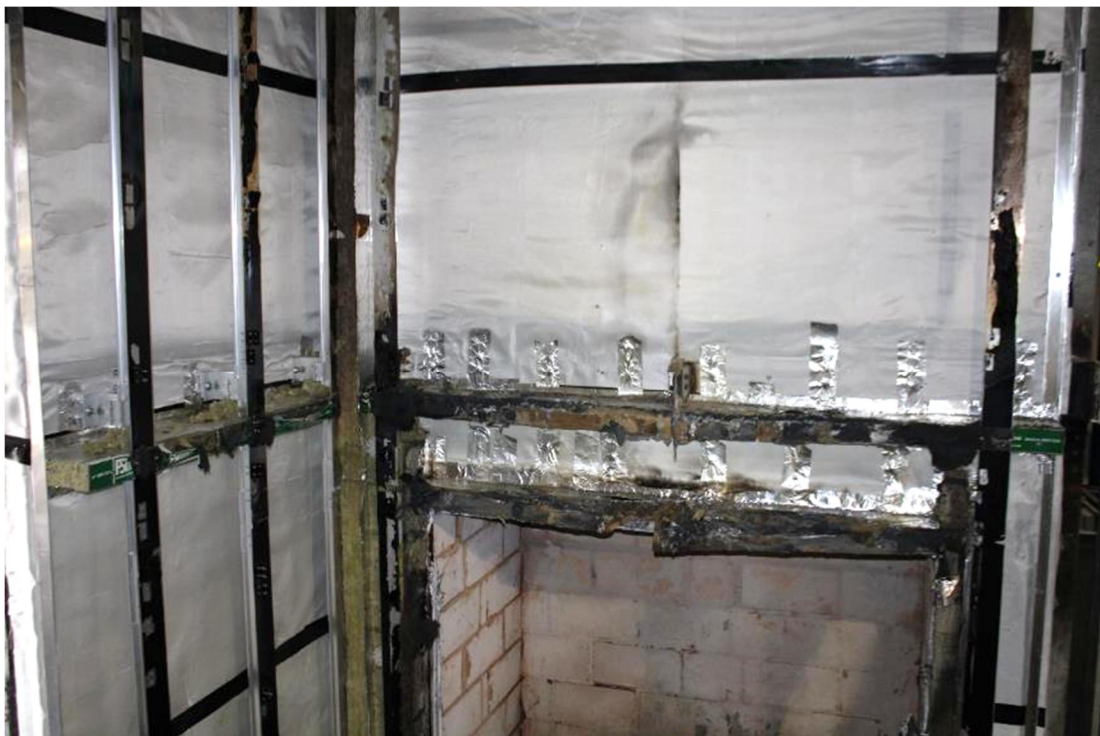
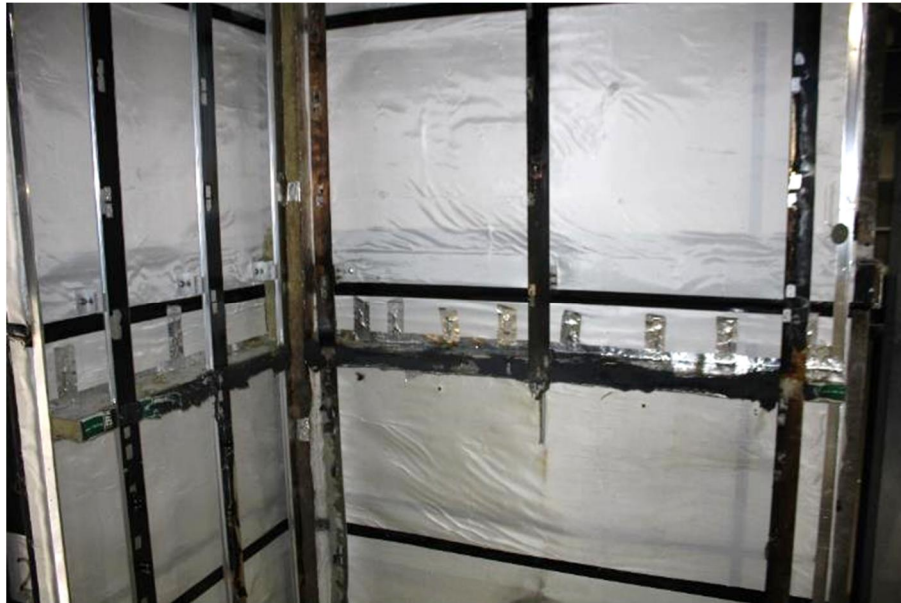
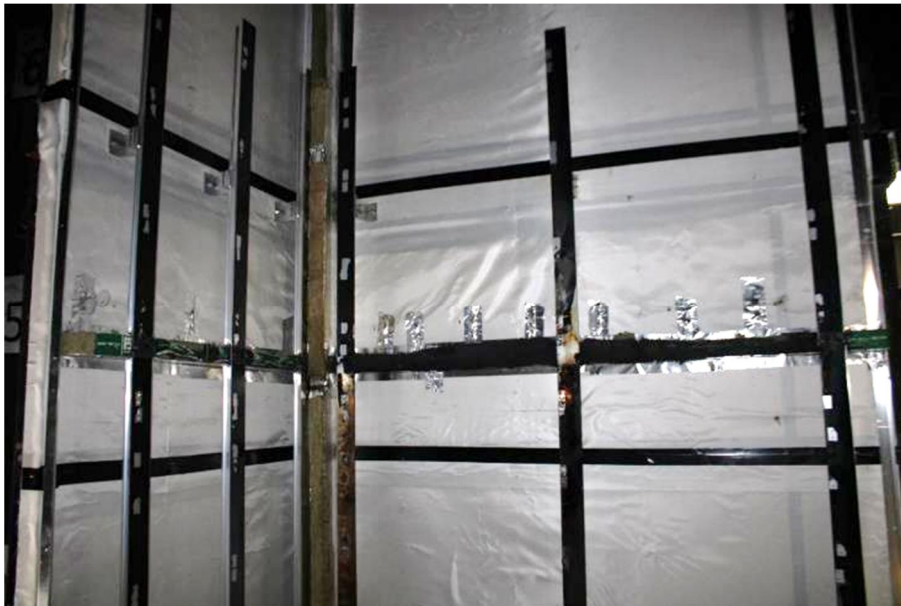
All horizontal cavity barriers remained in place. On the main wall, the horizontal cavity barrier directly above the combustion chamber opening, the intumescent strip had detached to full width. The horizontal cavity barrier located at 2490mm from ground, the intumescent strip had detached to approx. 1000mm-wide, the remaining intumescent strip had activated in line with the combustion chamber opening. The horizontal cavity barriers located at 4770mm and 6895mm from ground, the intumescent strip had activated to full width of the wall.

On the wing wall, all horizontal barriers had signs of activation to maximum 1000mm-wide.

The vertical cavity barriers remained intact and in place but were discoloured to up to 3000mm above combustion chamber opening.

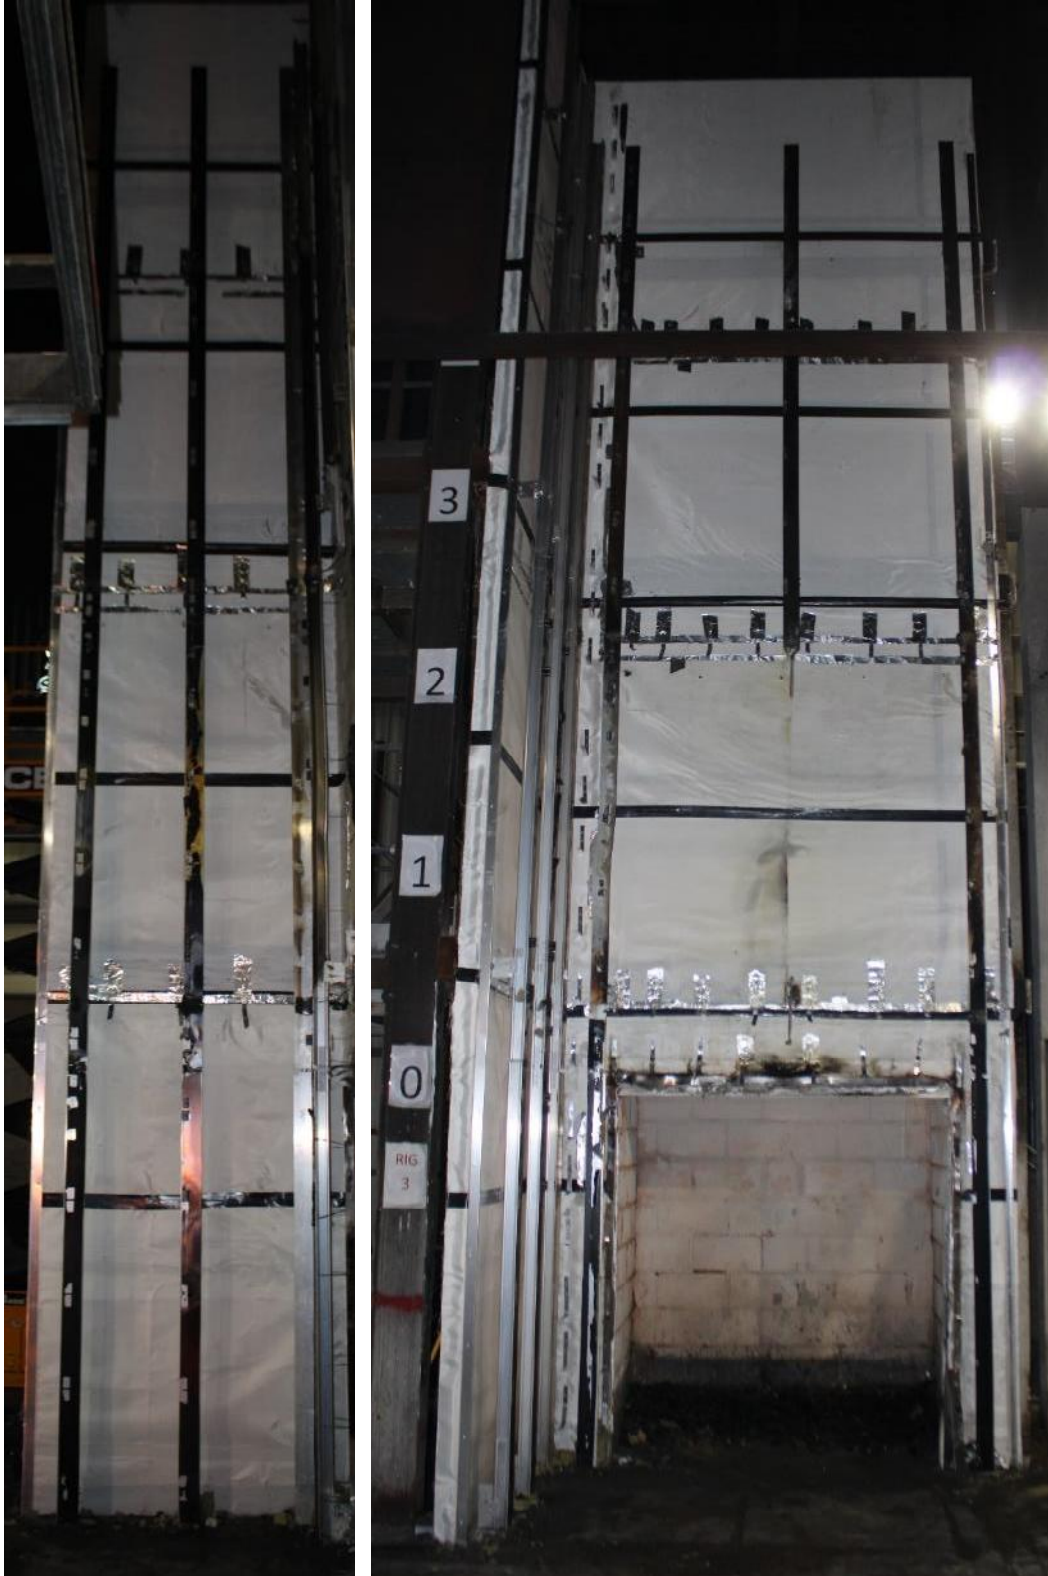
Damage to the 'T'-shaped rails on the main wall (numbered from left to right) was as follows:

1. Distorted at 1300mm above combustion chamber opening and discoloured to full height.
2. Melted up to 2500mm above combustion chamber opening. Discoloured to full height.
3. Discoloured to full height.

Damage to the 'T'-shaped rails on the wing wall (numbered from right to left) was as follows:

1. Discoloured from combustion chamber opening to full height.
2. Discoloured from combustion chamber opening to 2500mm
3. No visible damage.

The aluminium angles located at the top edge of the combustion chamber surround had melted to full width and the vertical edges distorted and discoloured to full height.

The aluminium angle located at the outside edge of the main/wing wall remained intact with no visible damage.

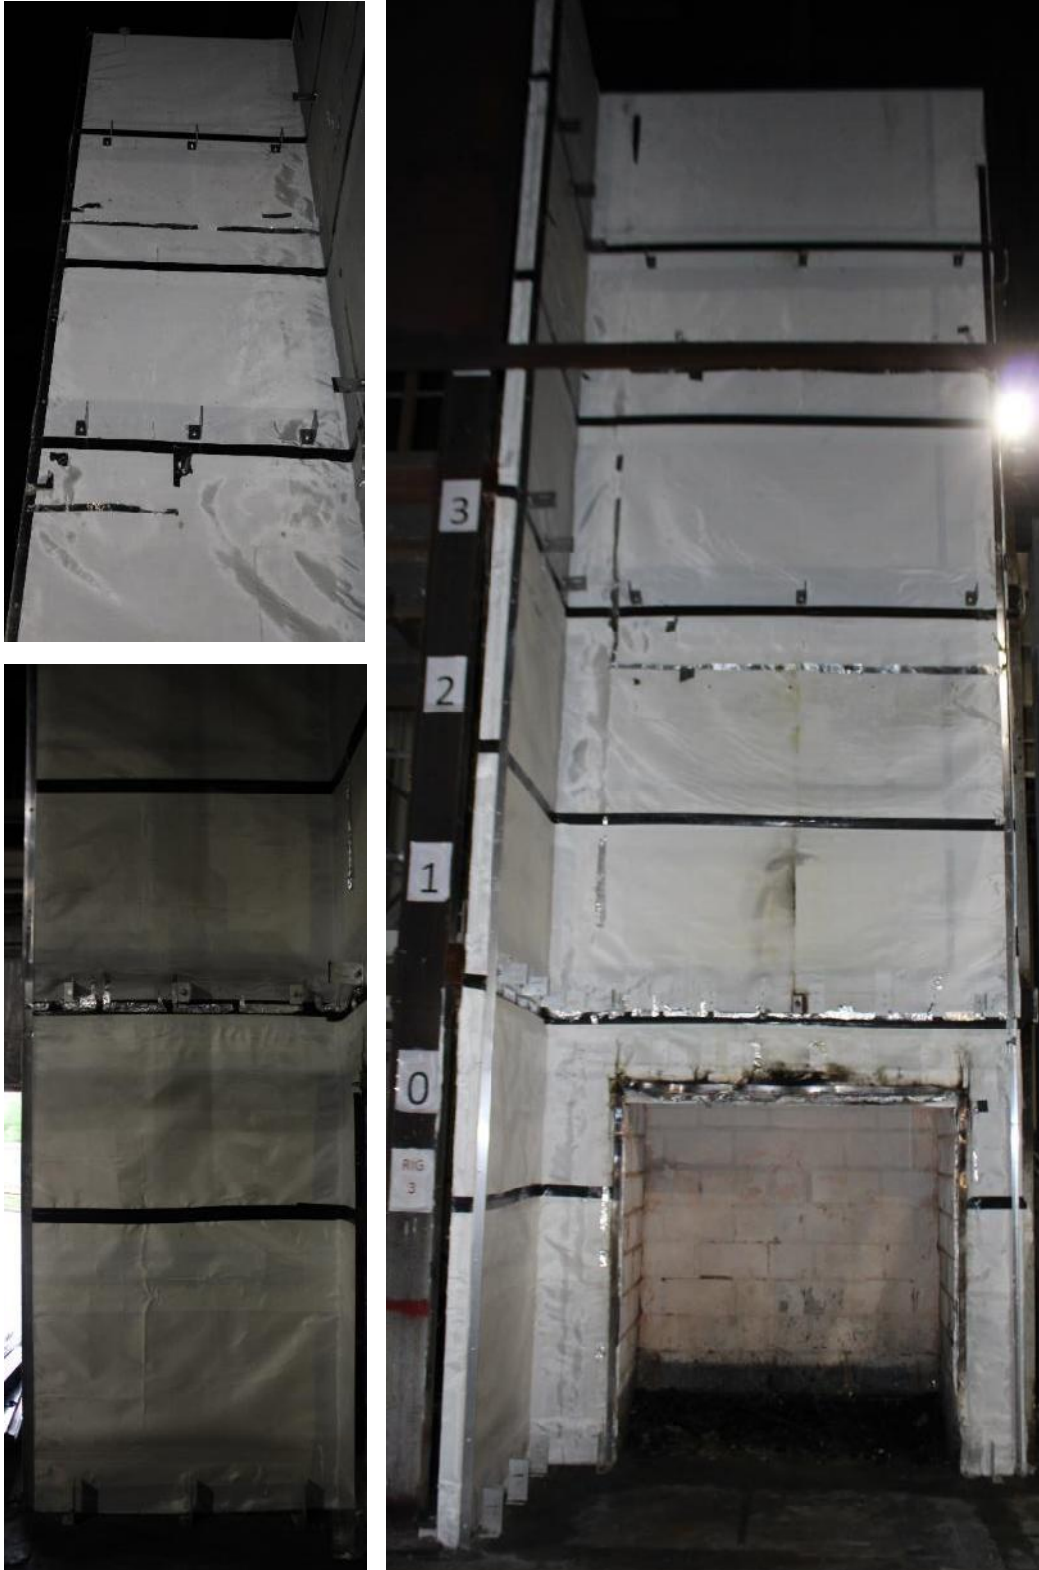
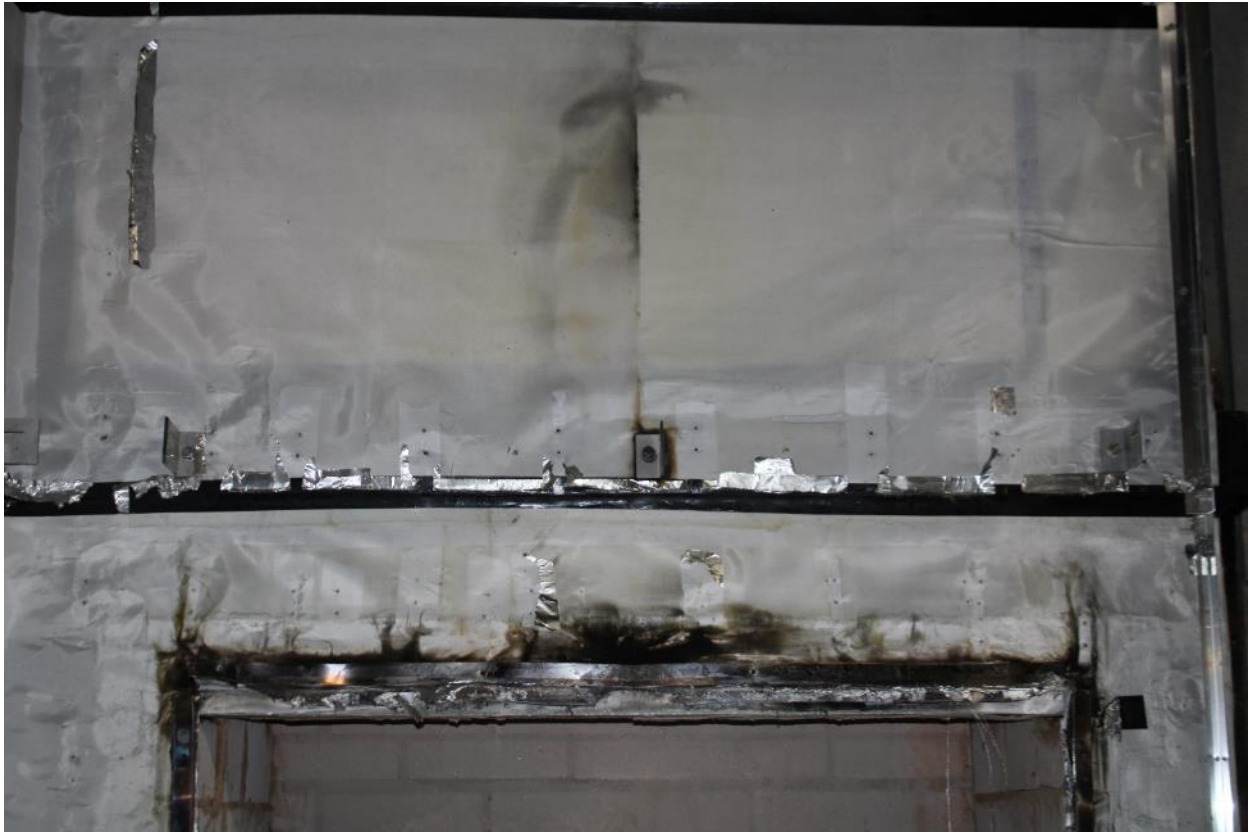
On the main wall, the brackets located at ground level had no visible damage. The brackets at all other levels had signs of discoloration to the tip.

On the wing wall, the brackets remained intact with no visible damage.

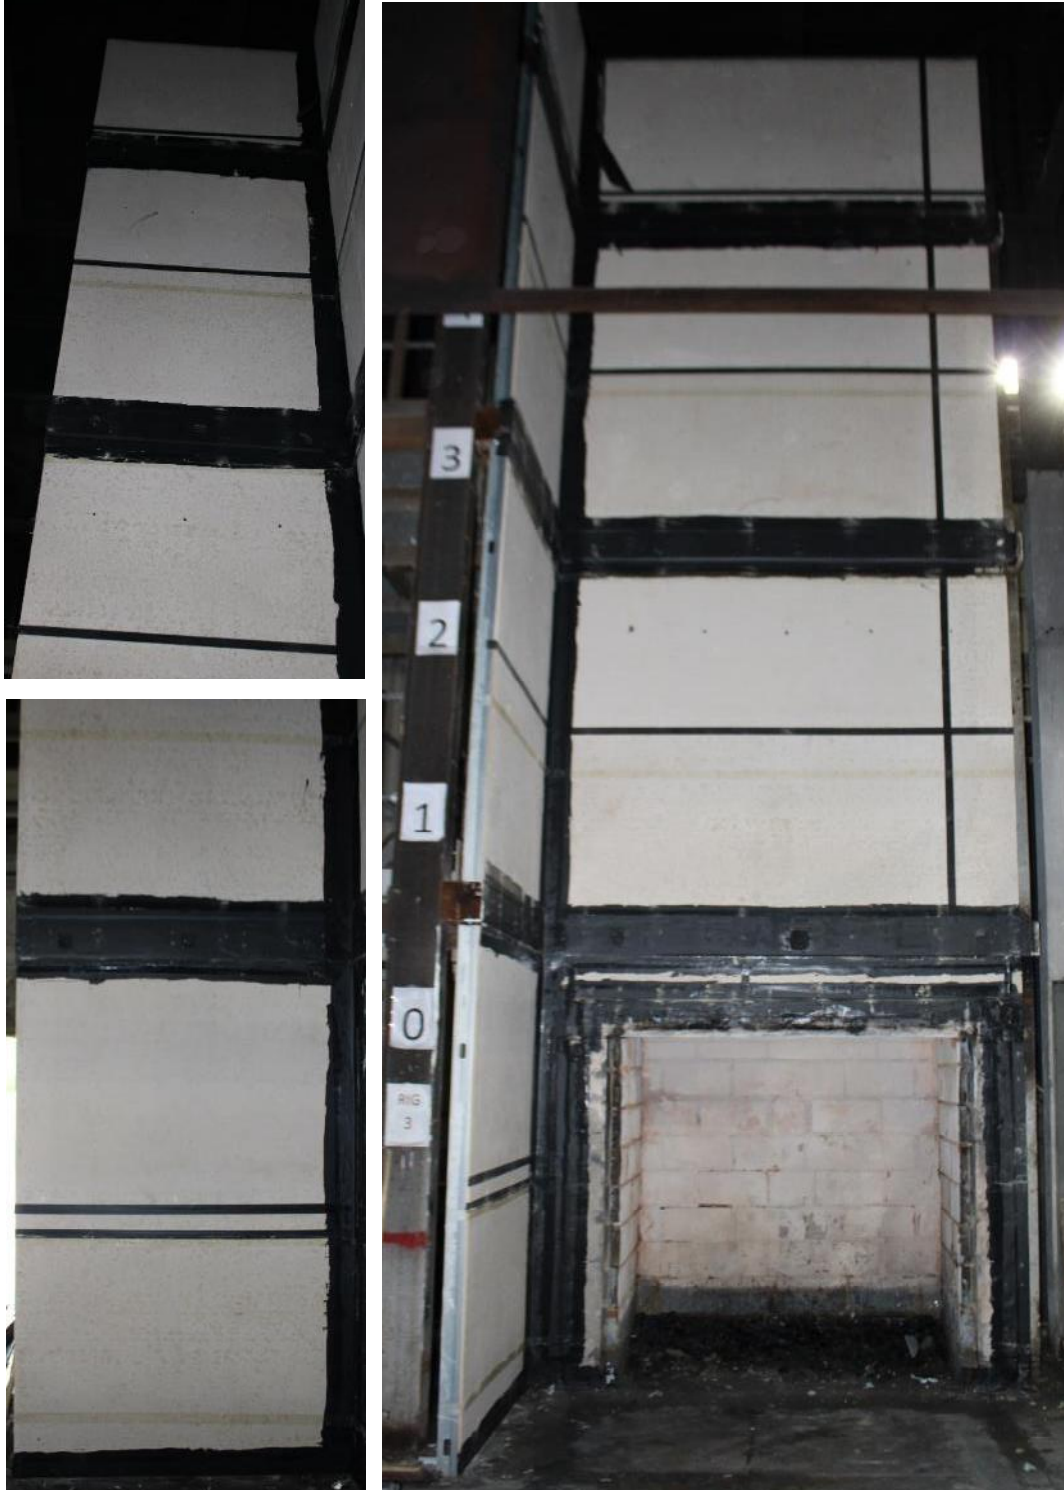
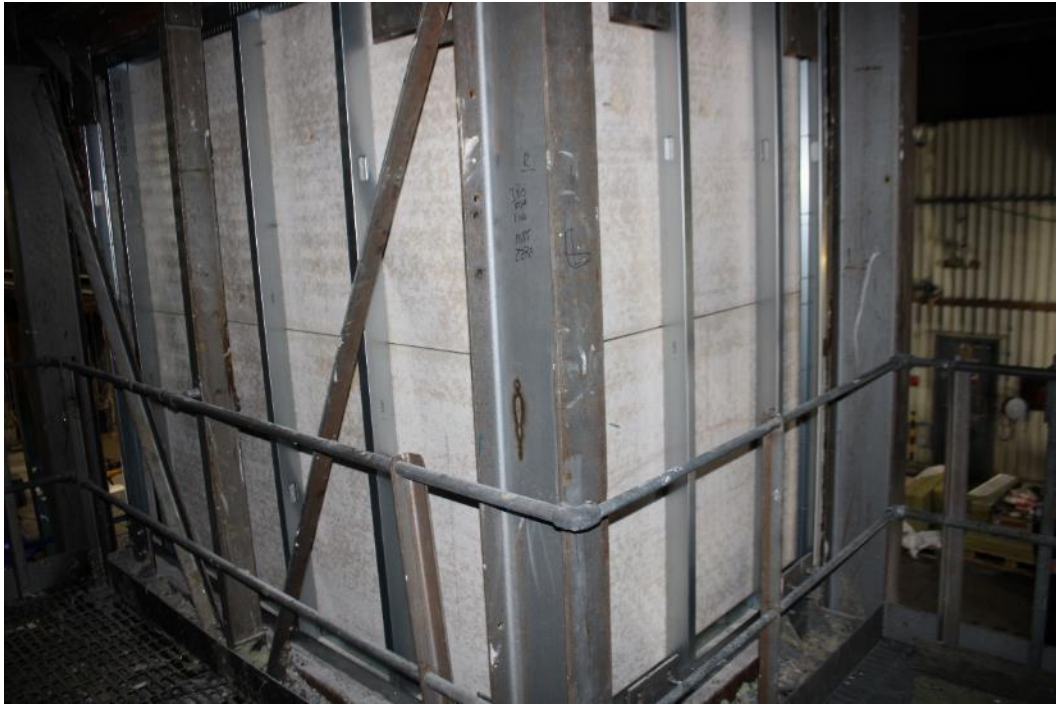
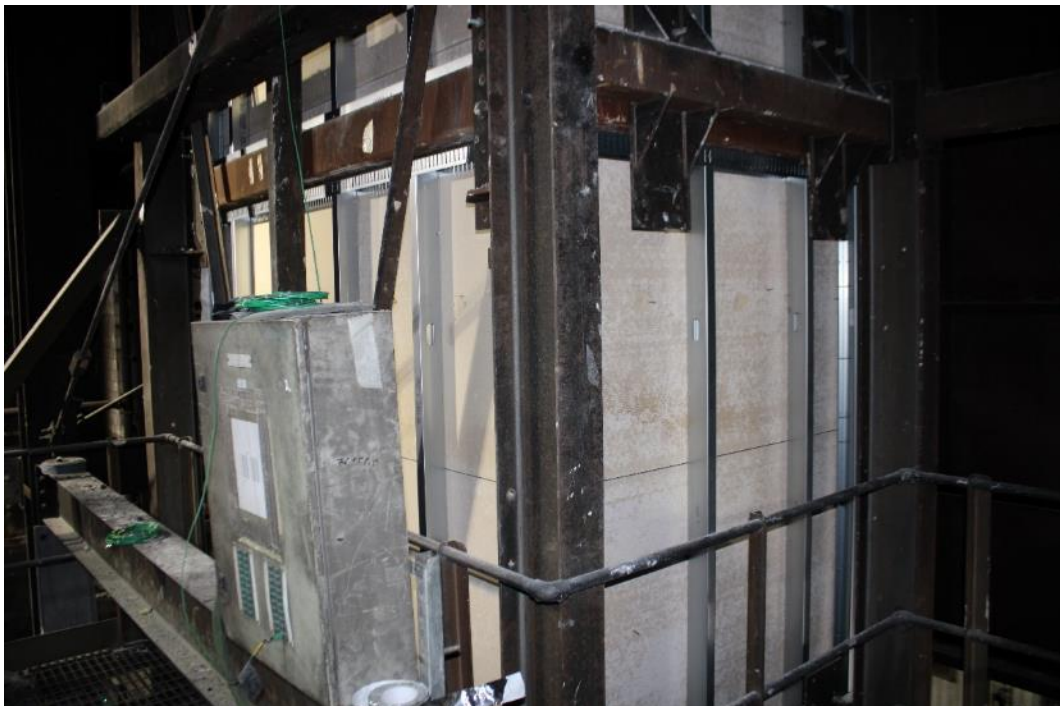
The EPDM membrane and sheathing board remained intact with no visible damage.

The rear of the sheathing board had no visible damage.
