BRE Global Test Report

BS 8414-2:2015 + A1:2017 Test on 3mm-thick aluminium cassette panels with 150mm-thick Rockwool Rainscreen Duo Slab insulation

Prepared for: SBS Cladding

Report Number: P119916-1000 Issue: 2

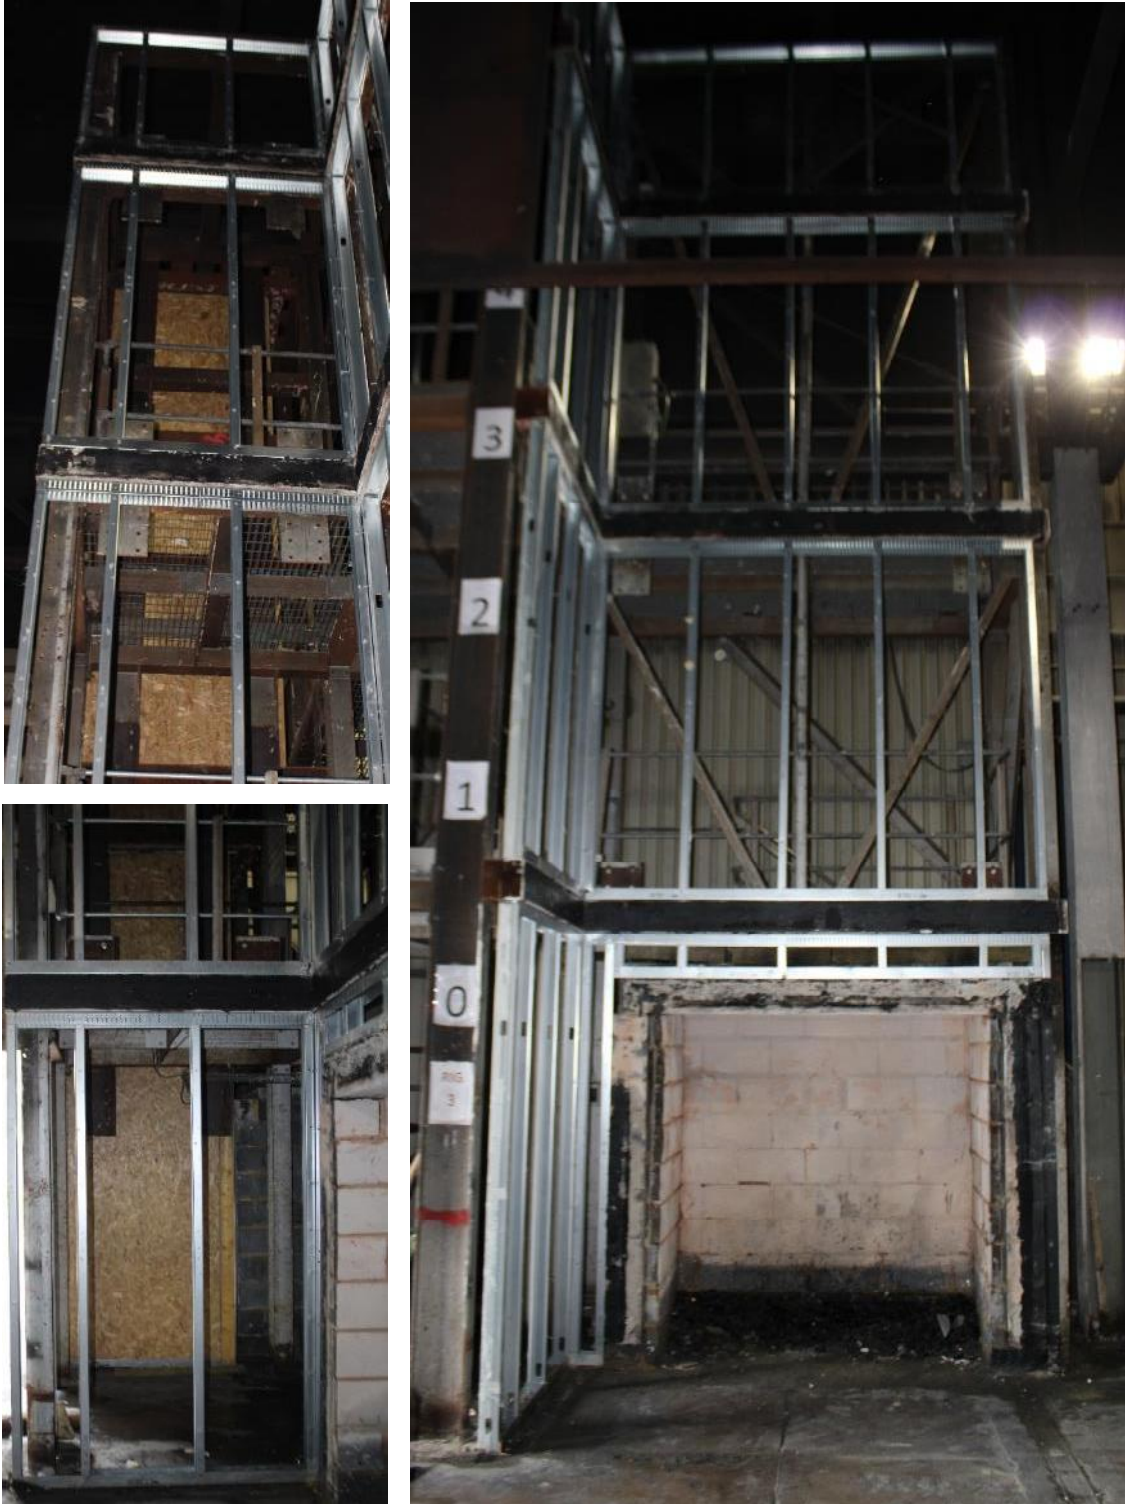
Figure 66. Full-height photograph of the Steel Framing System (SFS).

Remained intact with no visible damage.
